# Expansion Program: Project Definition Report

## Cloverley Elementary School

School District No. 44 (North Vancouver)  
November 10, 2022

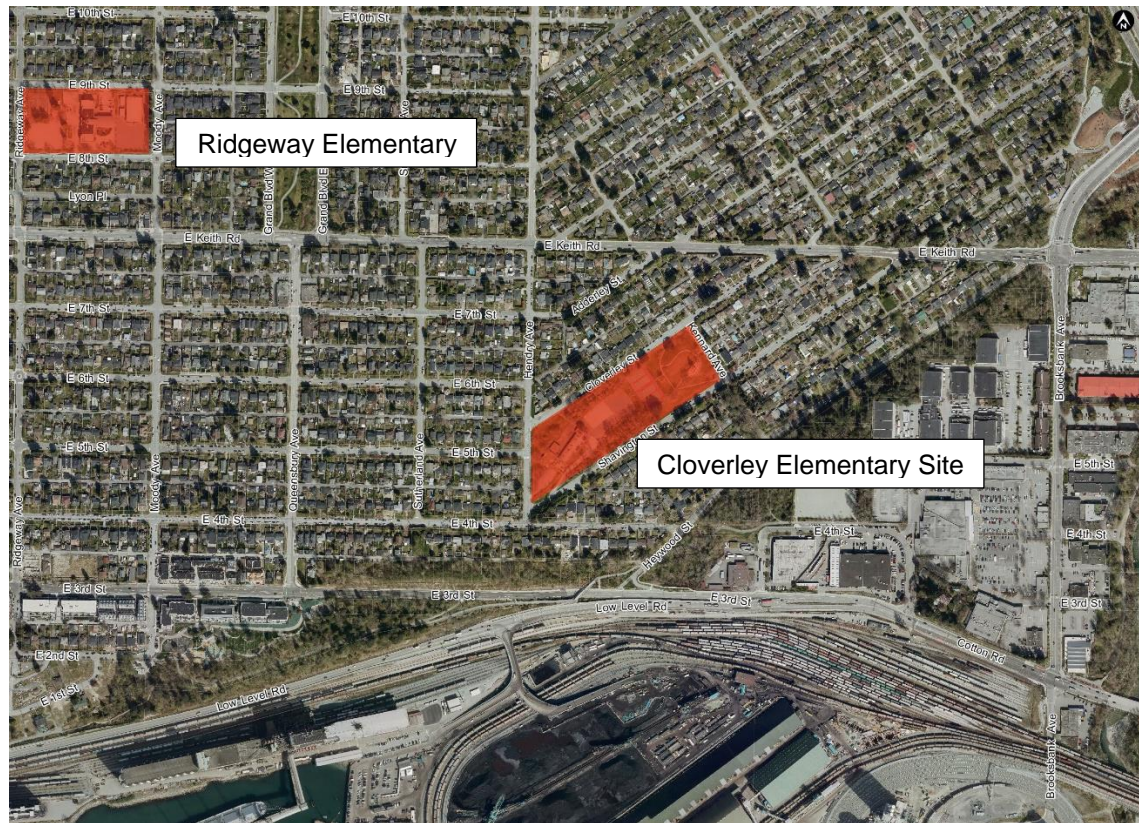
**Figure 3: Context Plan**

The former Cloverley Elementary School site is located at 440 Hendry Avenue, North Vancouver in the Moodyville neighbourhood. Cloverley was a public elementary school between 1961 and 1982. Afterwards, it was leased by various organizations until briefly returning to service between 2010 and 2014, while Queen Mary and Ridgeway Elementary Schools were under construction. Since then, the school has remained vacant and is considered beyond its useful life as noted in the 2017 VFA Asset Detail Report. The eastern portion of the site is currently leased to the City of North Vancouver (CNV) as park land. The park is known as Cloverley Park and includes tennis courts, a playground, walking trails, mature trees, lawn, and flat area suitable for outdoor games. The CNV has expressed preference to retain the existing community park amenities on the east side of the property, or alternatively replace the park on the west side of the property depending upon the location of the new school. The site is surrounded on all sides by single family residential houses and sits up on the hill above industrial areas along the waterfront.

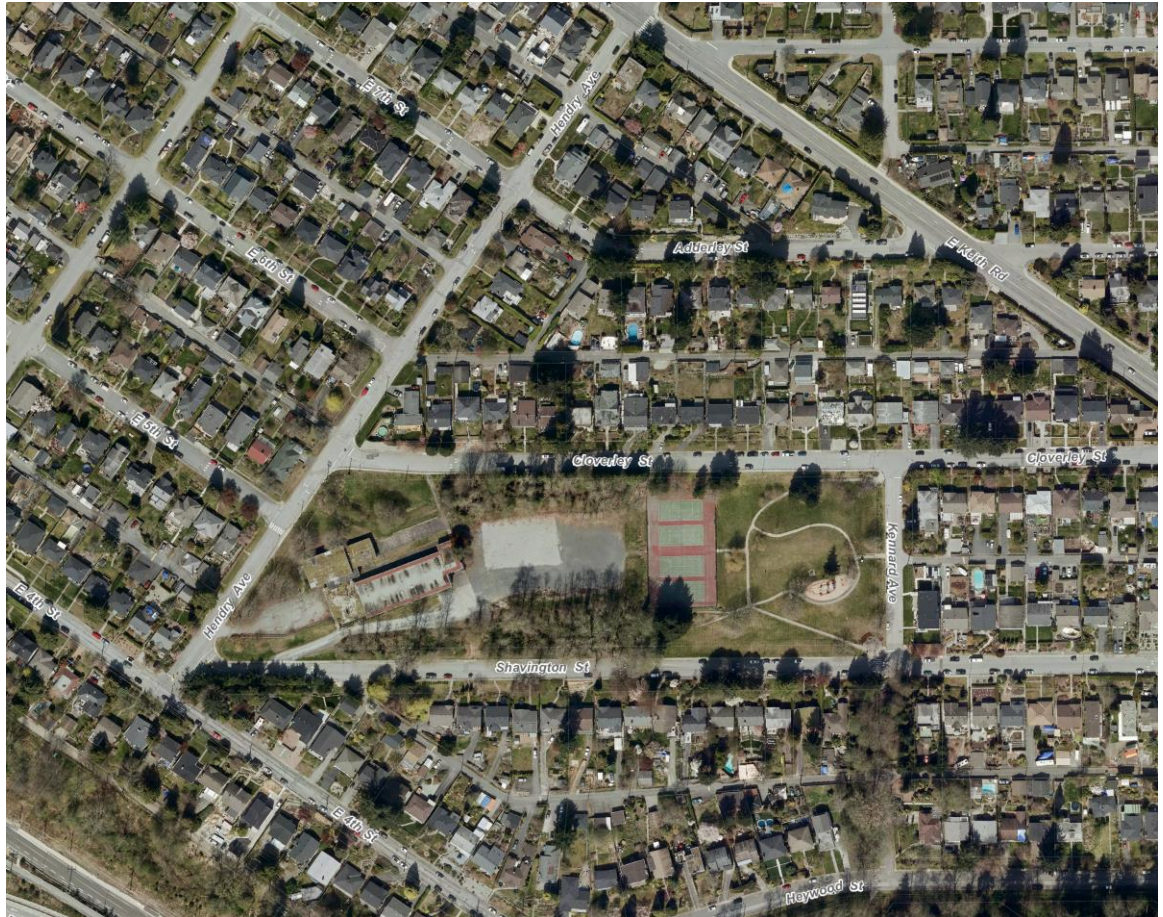
Figure 4: Existing Site Aerial

Currently, vehicular access to the site is located off Hendry Ave and is near the intersection of Hendry and Shavington Street. Vehicle traffic has been an ongoing concern within this neighbourhood as commuters often take shortcuts through this area to avoid congestion on nearby arterial routes. There are traffic barriers on Hendry Ave which partially blocks the south-bound lane from the parking lot access to impede and prevent east-bound commuter traffic flow. There are 28 paved parking stalls in the parking lot with one accessible stall. There is also a gravel access road to the south of the school accessed off Shavington St. The streets around the site are relatively quiet being located in a residential neighbourhood. A few blocks north of the site is Keith Rd E. which is a major roadway that has a TransLink bus route along it and leads to Highway 1. Any delays on the Ironworkers Memorial Bridge typically leads to congestion on major access routes in the North Shore.

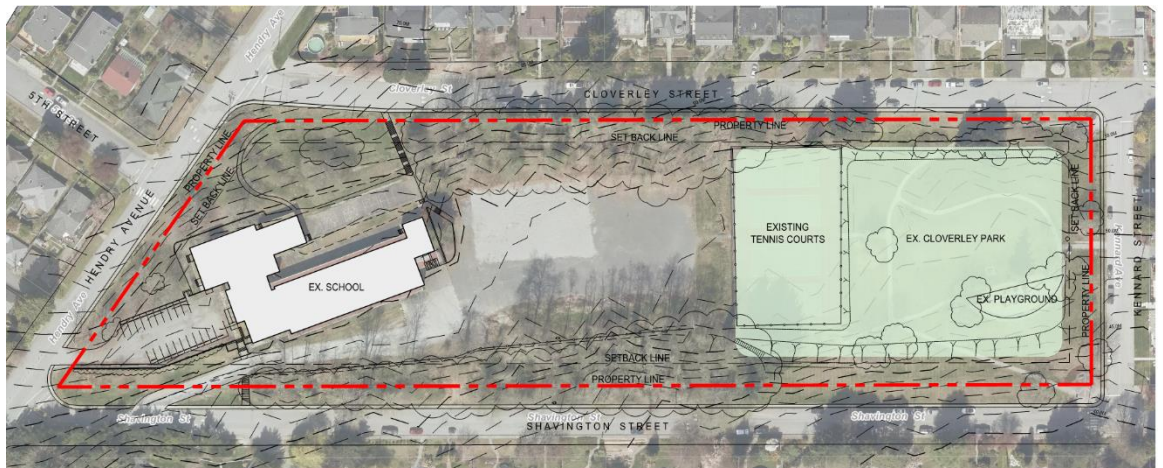
Figure 5: Existing Site Diagram

The subsurface conditions vary throughout the site. The soil consists of soft to firm silt, followed by compact to dense gravelly sand to sand and gravel, overlaying dense, weathered, till-like material which is generally comprised of sand with variable silt and gravel content. Till-like material was encountered between 3.0 m to 7.6 m depending on the location on site. Refer to the Geotechnical Report in Appendix D for more information.

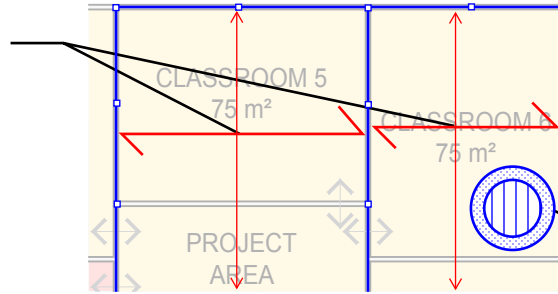
PROPOSED CLASSROOM FLOOR FRAMING

700DP OWSJ @  
1700o.c.

HSS 127x127  
columns

W250 rolled beams

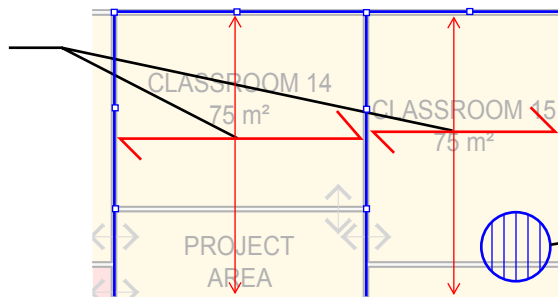
PROPOSED CLASSROOM ROOF FRAMING

600DP OWSJ @  
1700o.c.

HSS 127x127  
columns

W250 rolled beams

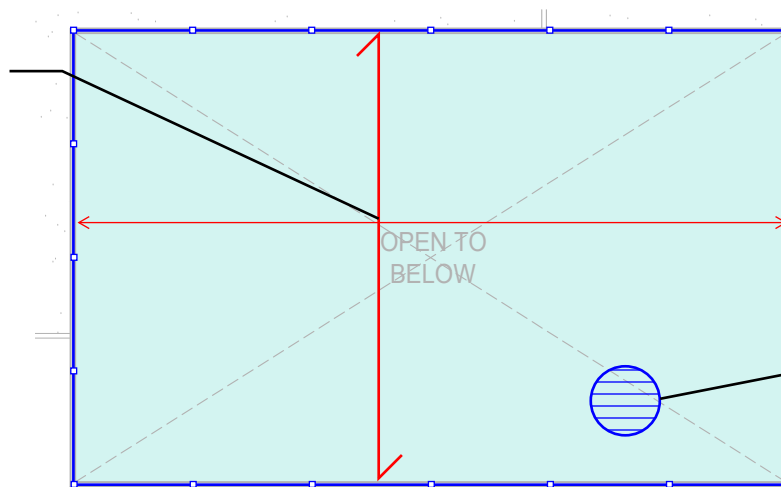
PROPOSED GYMNASIUM ROOF FRAMING

1400 OWSJ @  
2850o.c.

HSS 203x203  
columns

W250 rolled  
beams

76x0.91mm galv  
metal deck

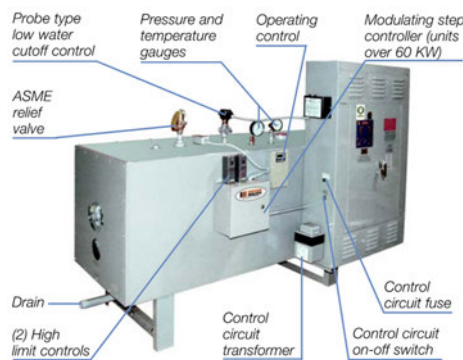
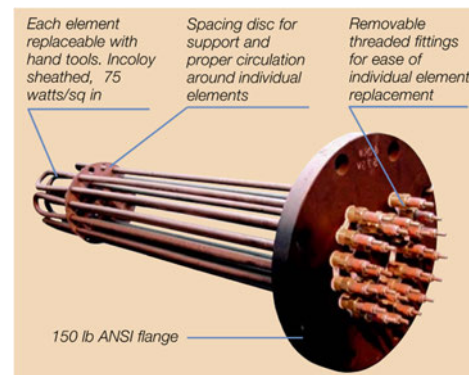
The proposed heating equipment will be installed in the Boiler Room. These boilers will be able to handle 100% of the heating load on the design heating day without requiring the air source heat pump to operate.

The building heating plant will consist of two electric boilers Bryan model BE-240 or similar. Each boiler is to have a nominal output of 230kW [786 MBH].

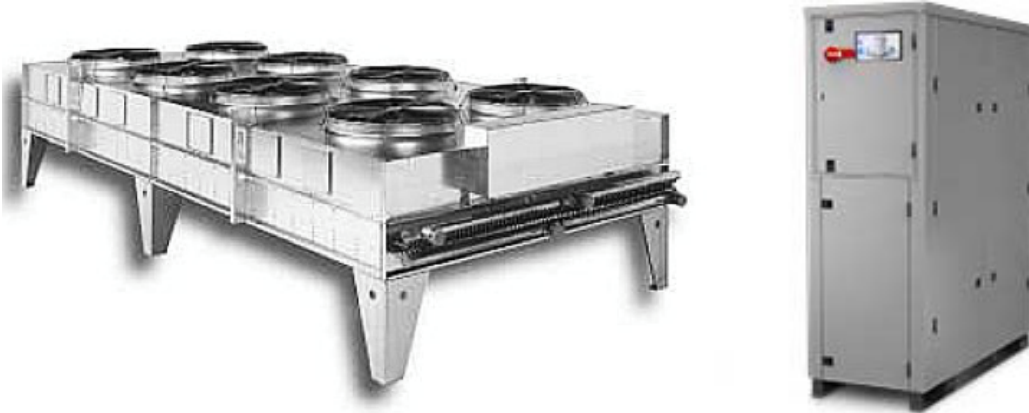
Two 50 ton reversible water to water heat pumps [total 100 tons] will be installed to provide heating and cooling for the building systems. These heat pumps will extract heat from the air and transfer it to the ERVs and air handling units as required. When cooling is required they will use the same fluid cooler and piping to reject heat and will supply chilled water to the areas requiring cooling including all of the ERVs.

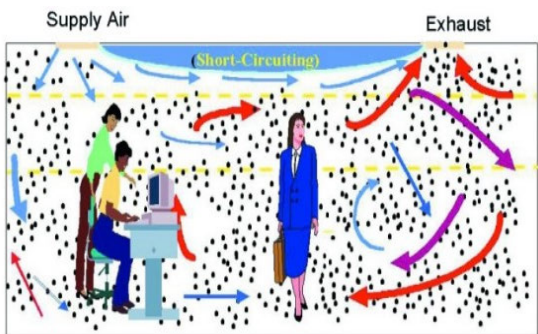
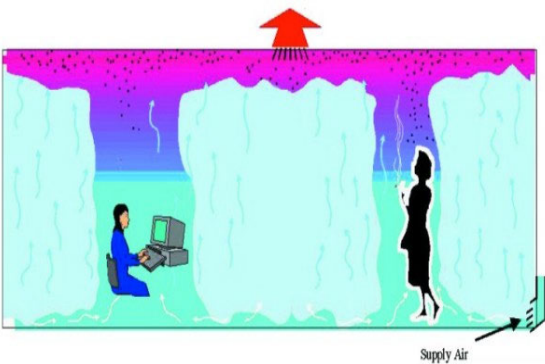
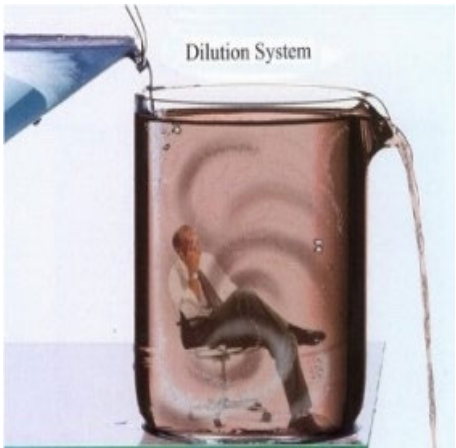
OVERHEAD AIR DISTRIBUTION SYSTEM

The ventilation design provides both improved indoor air quality and lower energy costs than conventional, overhead, ventilation systems which supply air overhead.

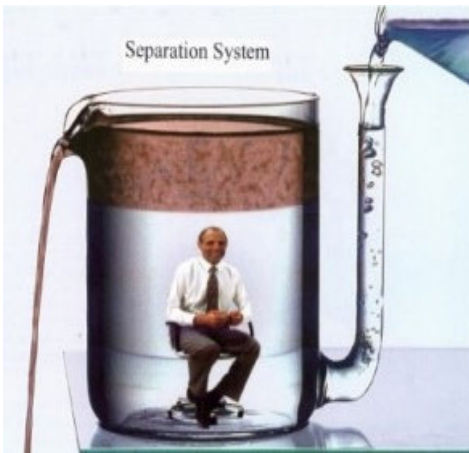
DISPLACEMENT AIR DISTRIBUTION SYSTEM

### VENTILATION COMPARISON

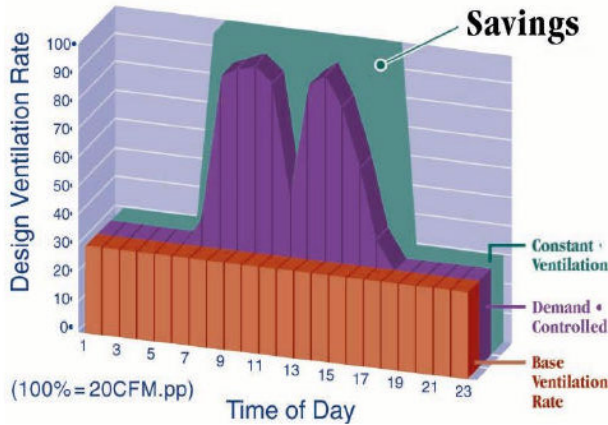
SAMPLE VENTILATION SAVINGS CHART

Motion detectors shall be installed in all classrooms and major rooms to reduce the outdoor air volumes when the rooms are unoccupied. A variable air volume terminal will be installed for each classroom to control the air volume supplied to the room [controlled by motion and CO<sub>2</sub> sensors].

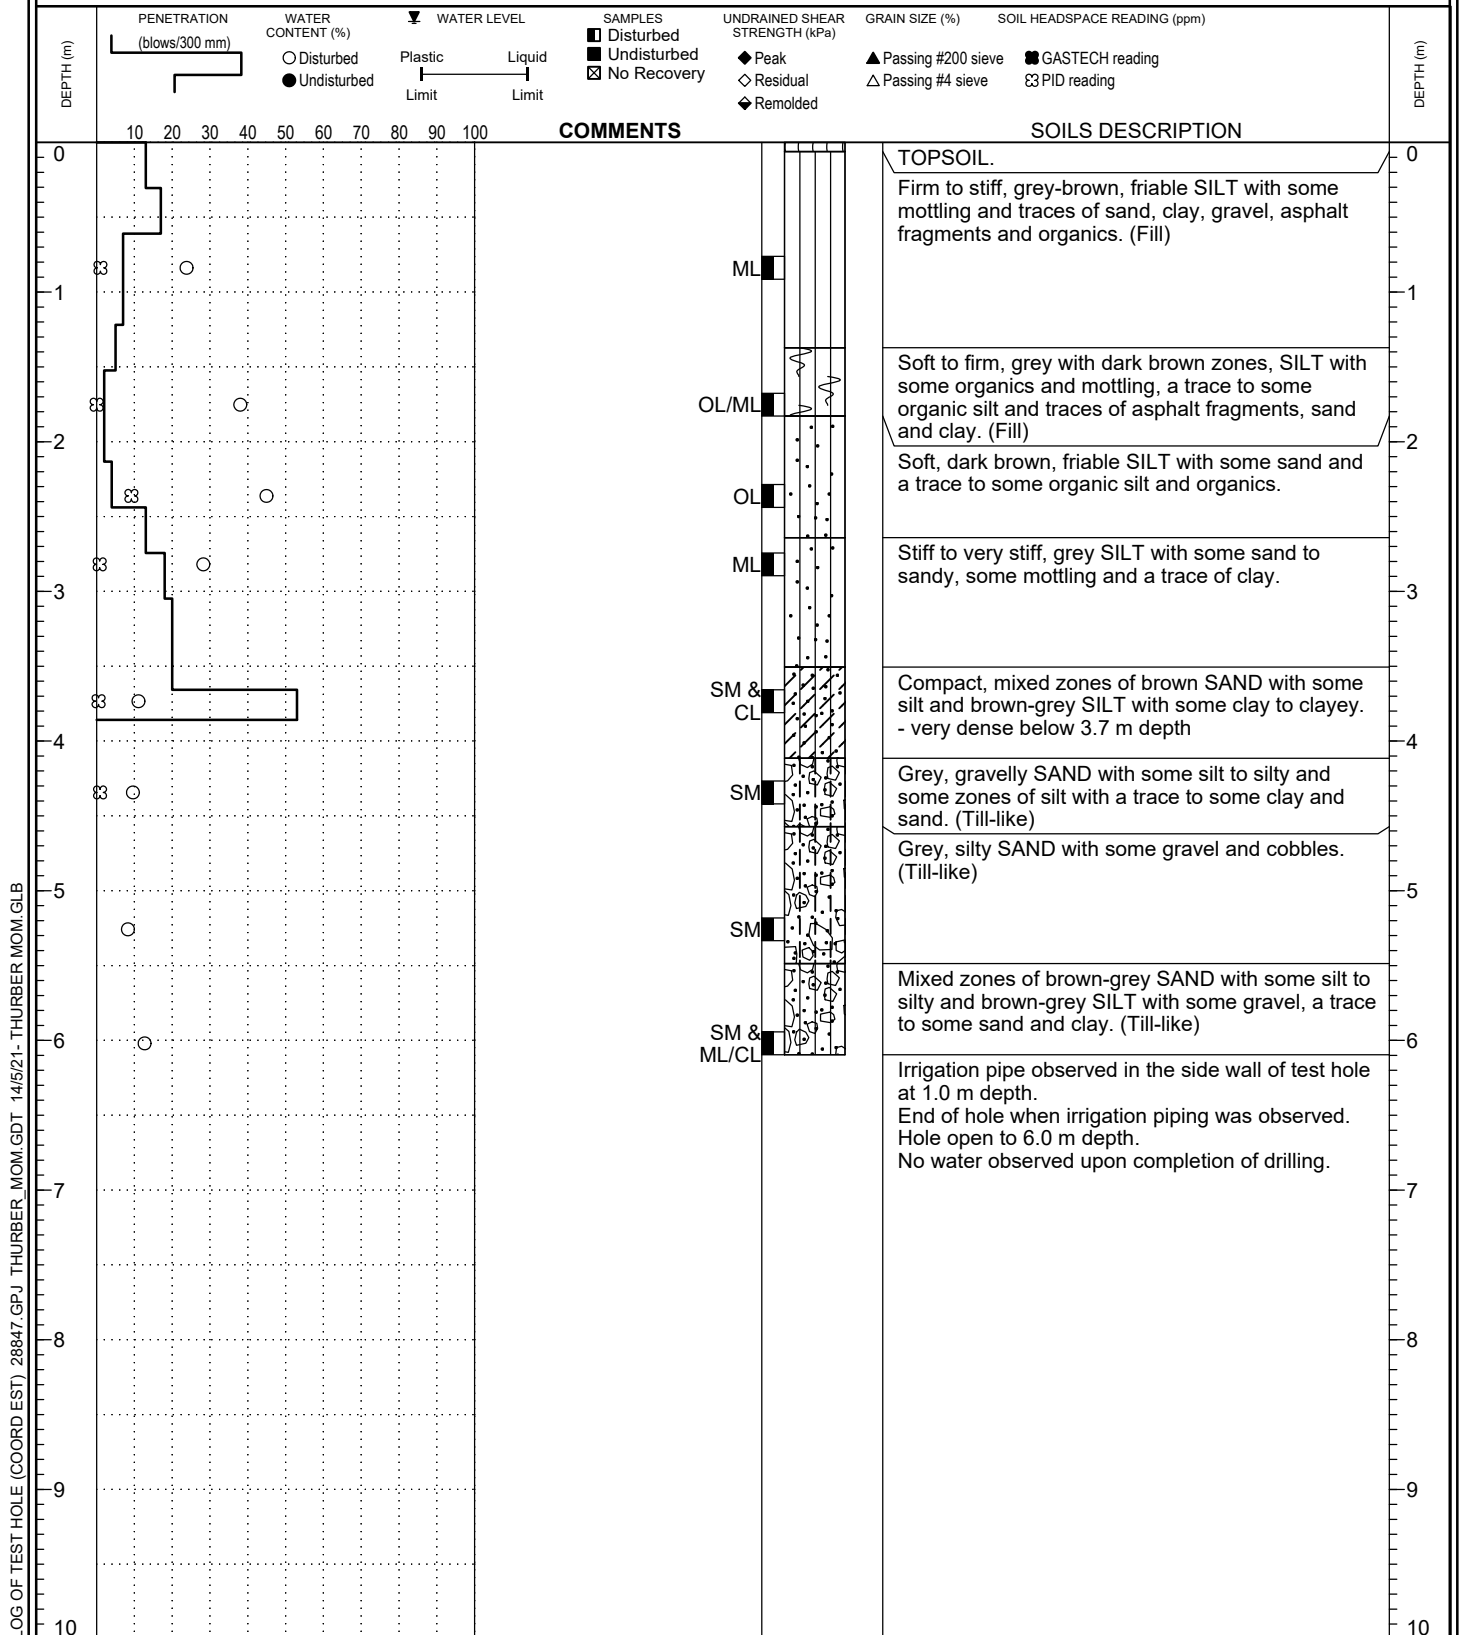
# LOG OF TEST HOLE

TEST HOLE NO.  
**TH21-03A**

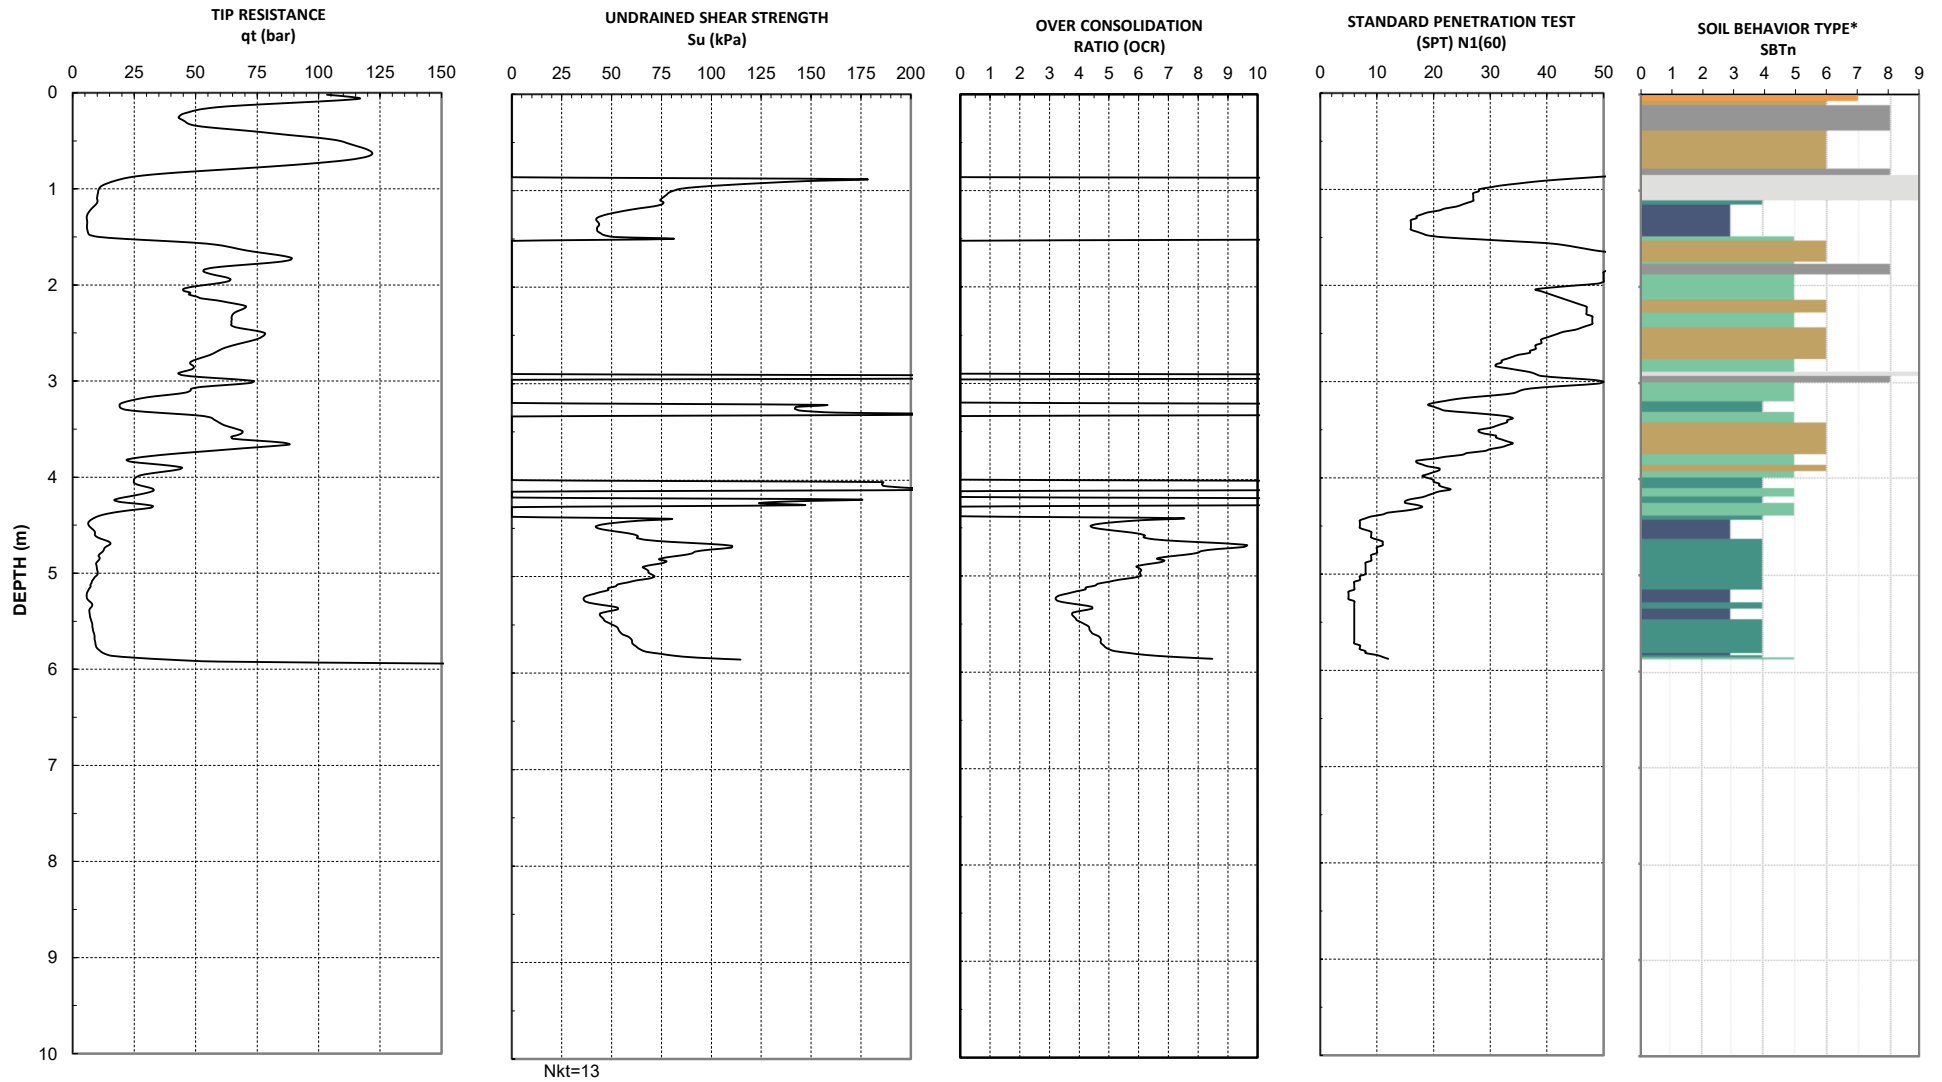
Site: 440 Hendry Avenue, North Vancouver, BC

\* Based on Robertson et. al 1990

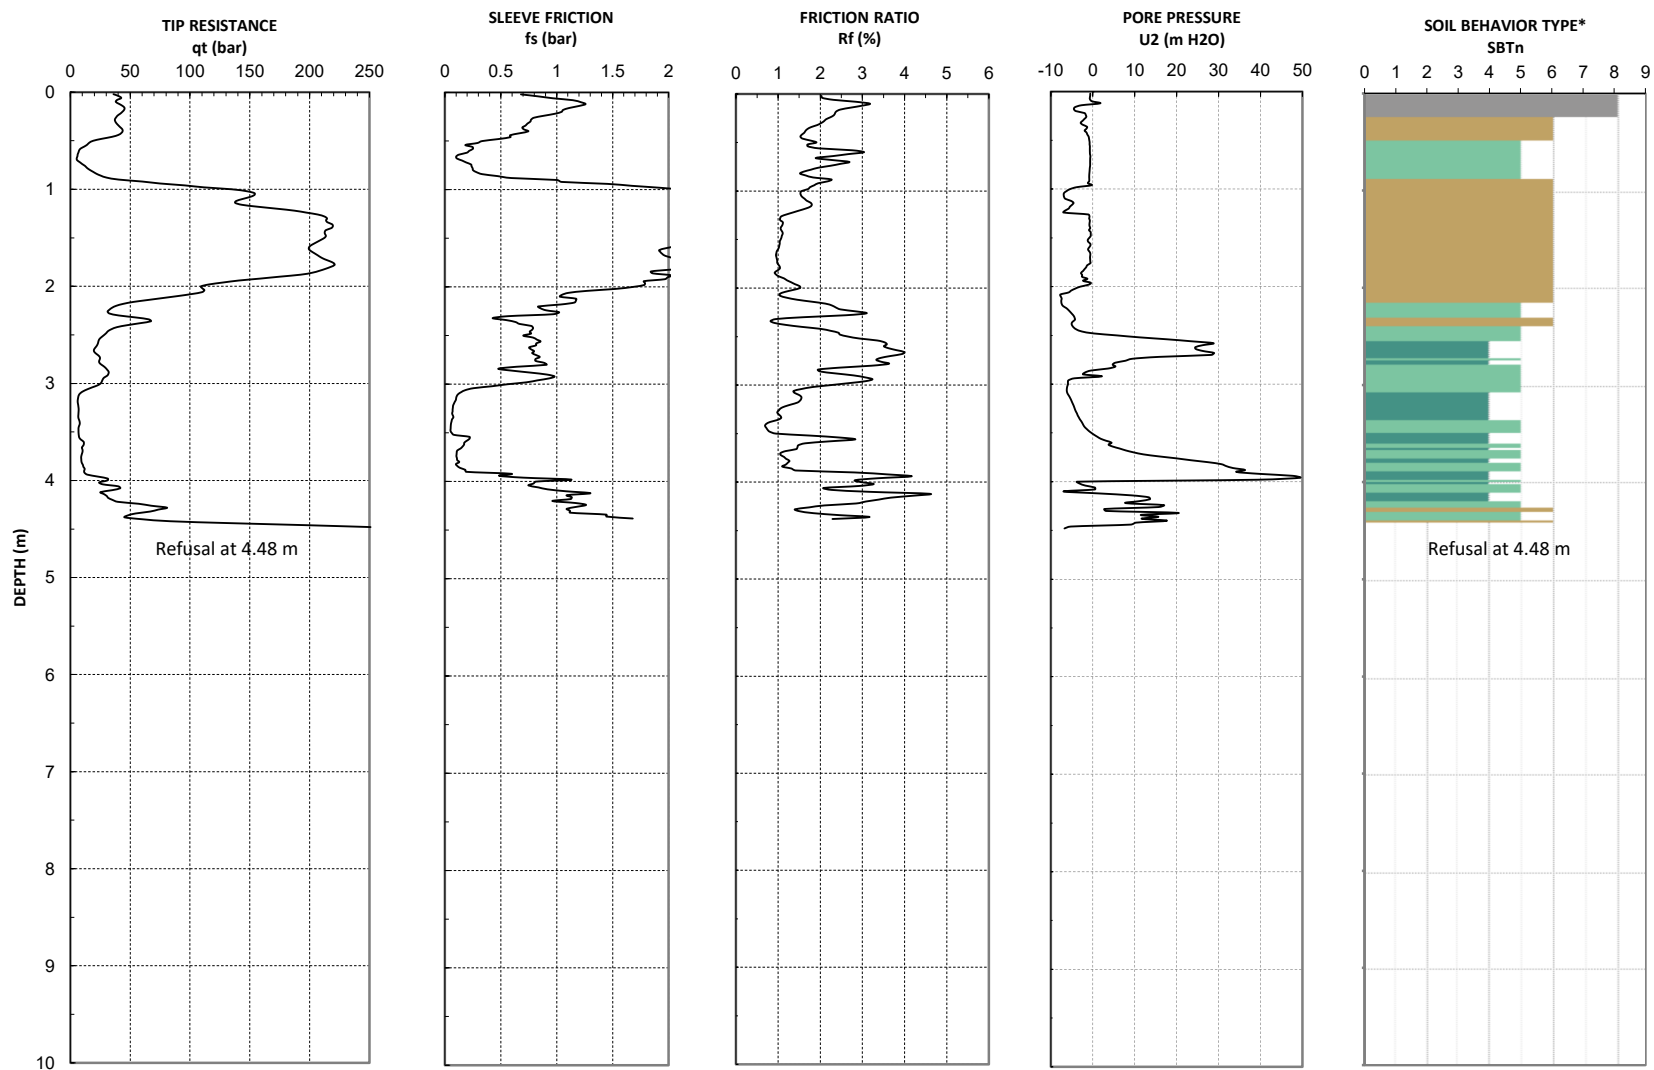
Site: 440 Hendry Avenue, North Vancouver, BC

\* Based on Robertson et. al 1990

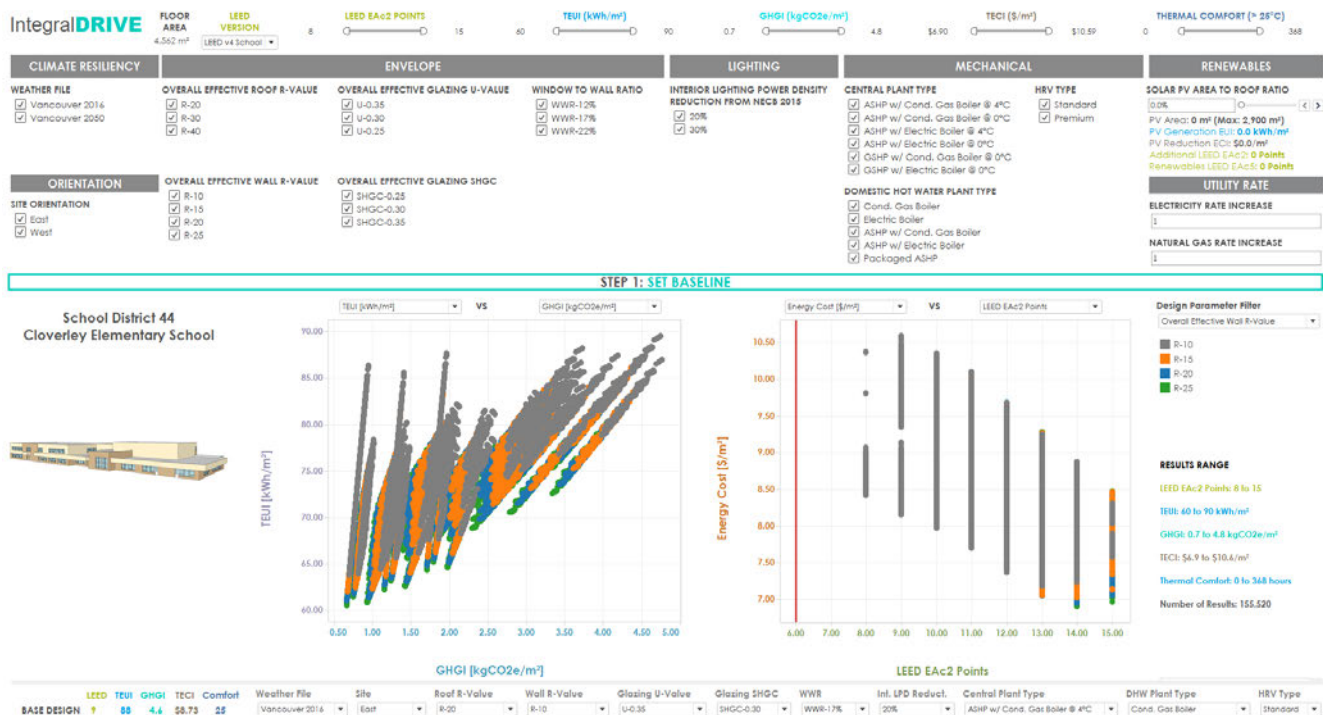
**Step 3:** Perform all possible combinations of the finalized design options with the help of cloud computing to shorten the simulation time. Present the energy modelling results to the design team with the in-house developed presentation platform.

**Figure 3.1: Overview of Parametric Energy Study Presentation**

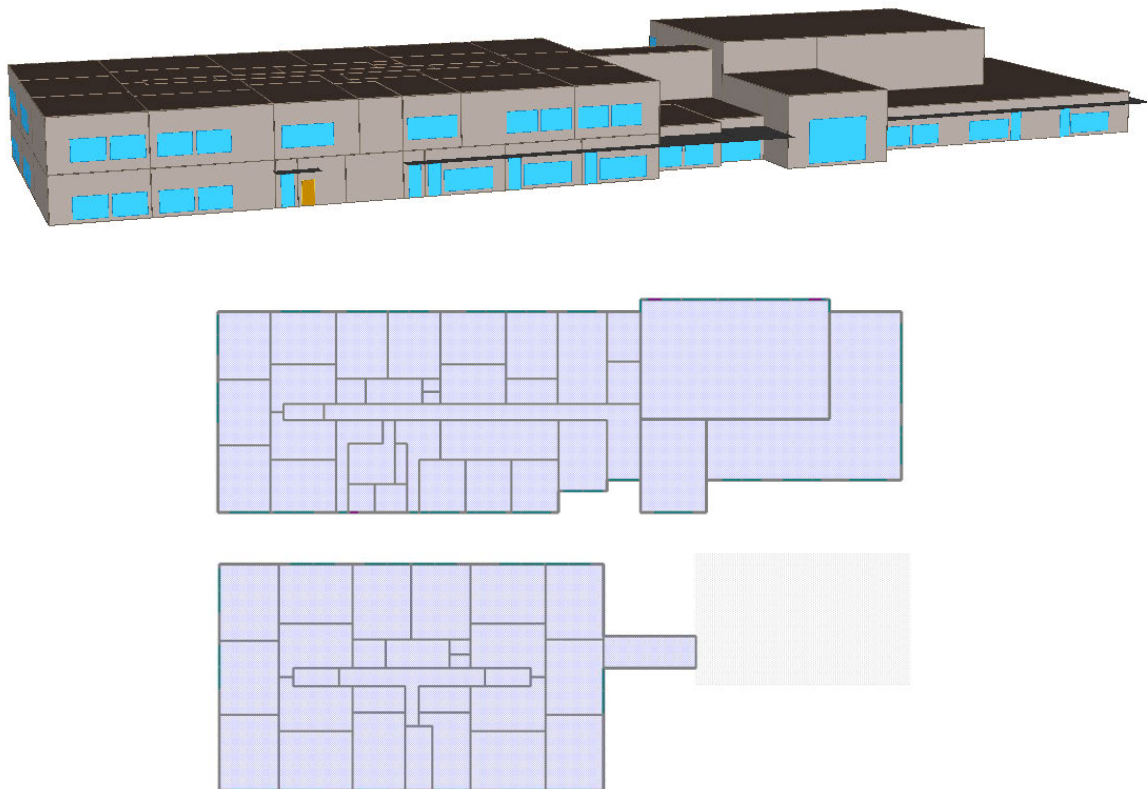
The energy model was developed using eQuest 3.64 building performance simulation software. eQuest conducts hourly building thermal and energy use calculations using 3D model inputs, detailed envelope constructions, internal thermal gains, infiltration air flow, detailed HVAC network inputs, and industry standard hourly weather files. Please refer to Appendix A for more detail model inputs.

For reference purposes, a 3D rendering of the building as well as 2D floor plans in the energy modelling software are shown below.

**Figure 4.1: Energy Model Geometry**

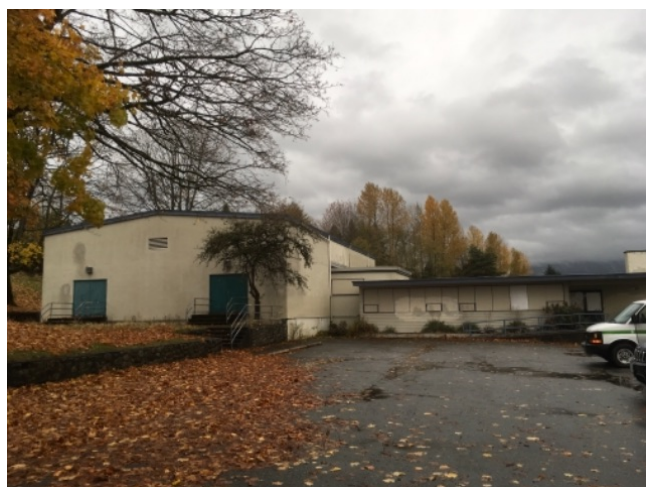
CLOVERLEY ELEMENTARY

The substructure consists of a reinforced concrete perimeter crawlspace foundation and some basement walls on reinforced concrete strip footings as well as interior foundations and footings. The facility also includes a concrete skim coat at the crawlspace floors with concrete slab on grade at the lower level corridor and classrooms.

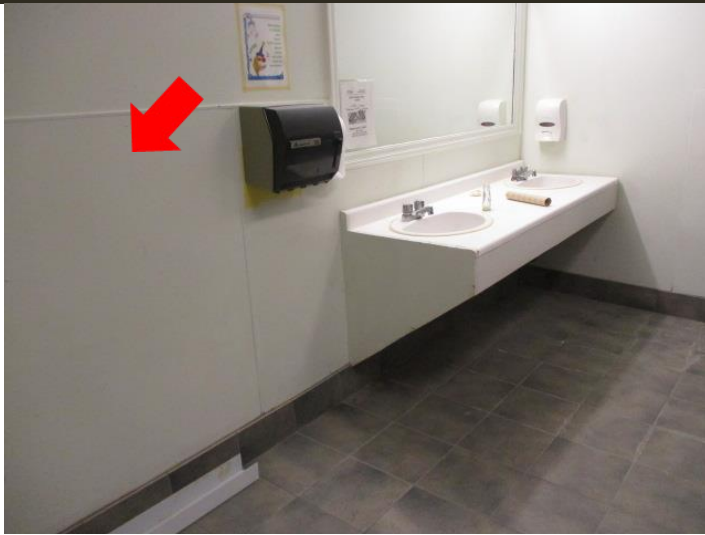
Photo 1 | Location: Typical Washrooms

Description: Asbestos Containing Cement Wall Board

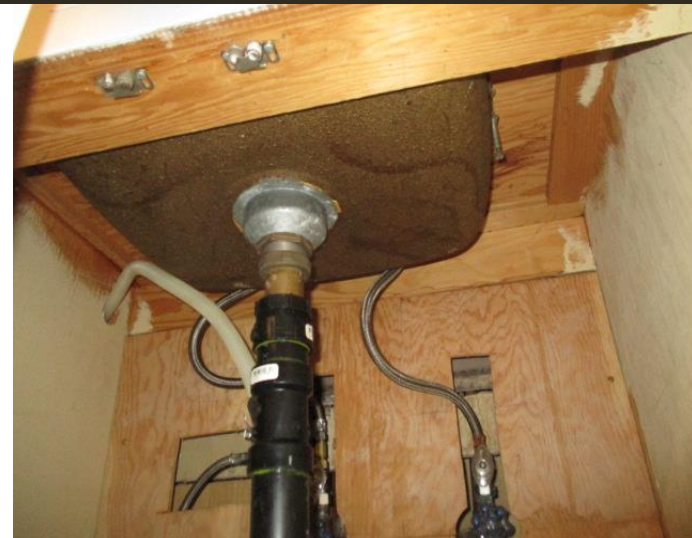
Photo 2 | Location: 1<sup>st</sup> Floor – Room 138 (125) – Kitchenette

Description: Asbestos Containing Sink Undercoating

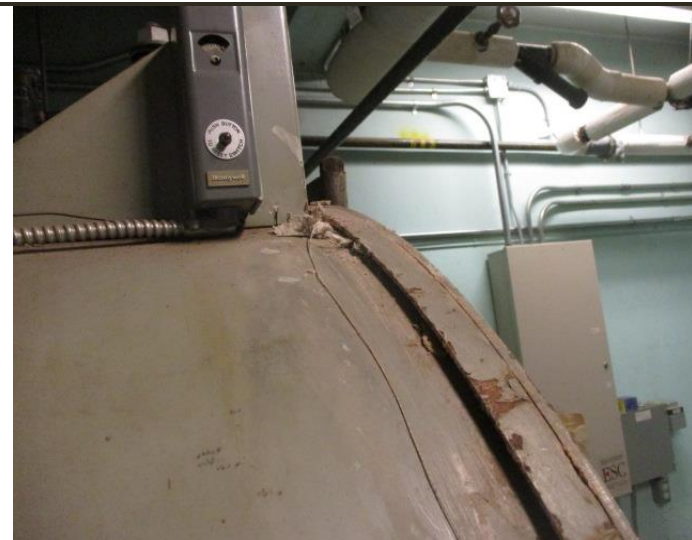
Photo 3 | Location: Basement – Boiler Room 003

Description: Asbestos Containing Gasket on Exhaust

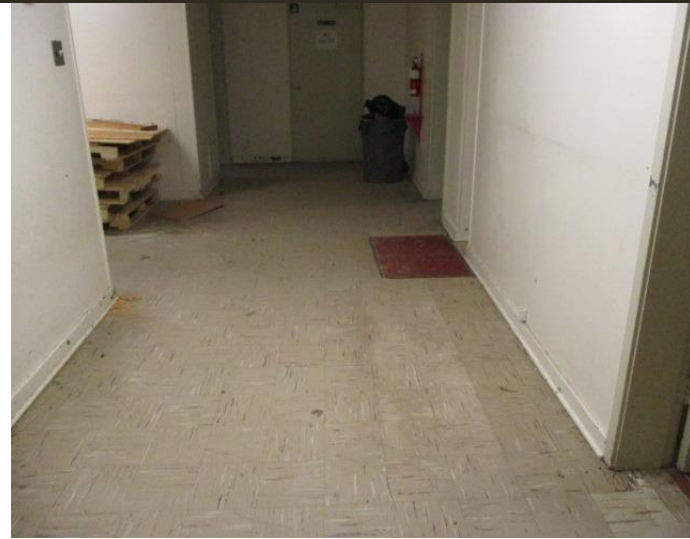
Photo 5 | Location: Basement – Custodian Room 002

Description: Asbestos Containing 9"x9" Vinyl Floor Tile

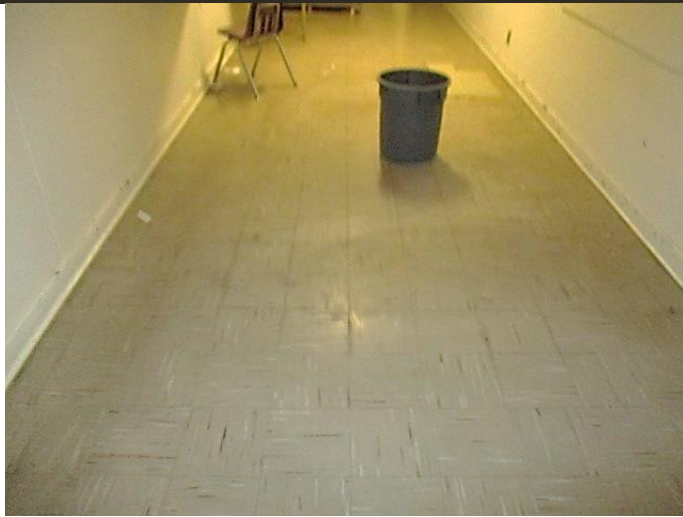
Photo 12 | Location: Basement – Classroom 002

Description: Asbestos Containing 9"x9" Vinyl Floor Tile

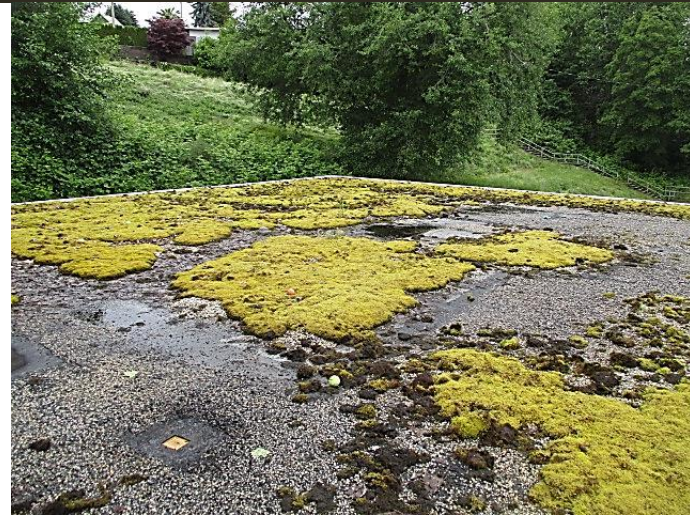
Photo 17 | Location: Roof

Description: Non-Asbestos Roof Membrane

Samples of roofing materials were not collected as the building is in use and the collection of the sample may affect the integrity of the roof membrane. Samples of the roofing material should be collected for identification when the roof is replaced or is disturbed during renovation, demolition or repair work.

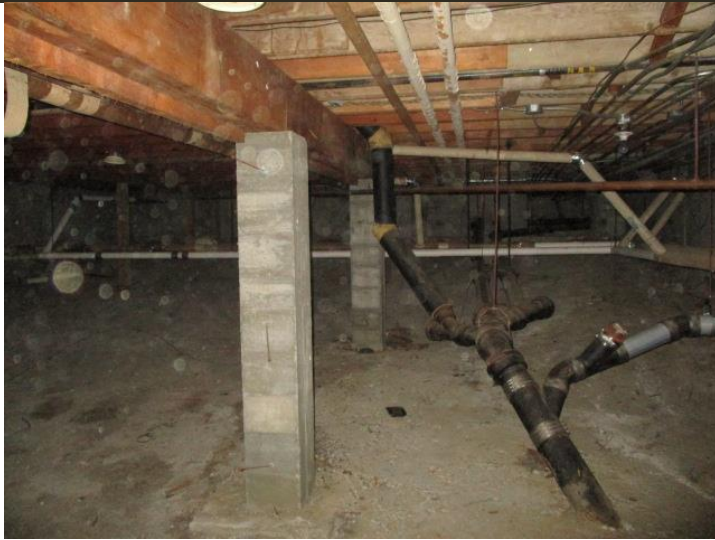
Photo 20 | Location: Crawlspace Below Gymnasium

Description: Asbestos Containing Pipe Elbows & Fittings

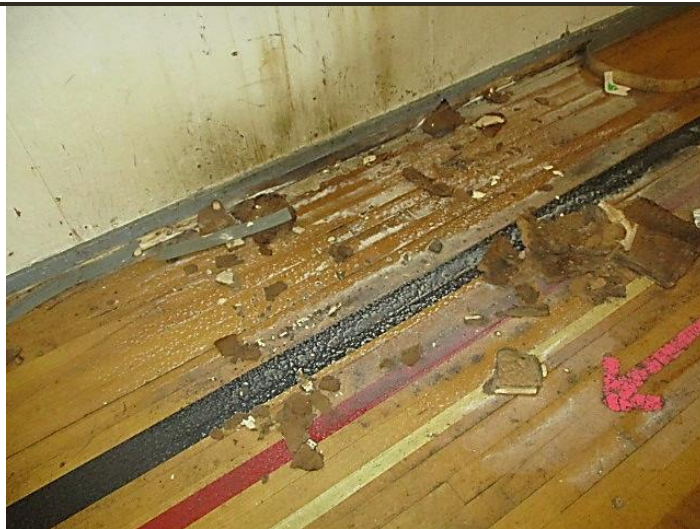
Photo 22 | Location: Gymnasium  
Description: Water Damage to Wall & Ceiling

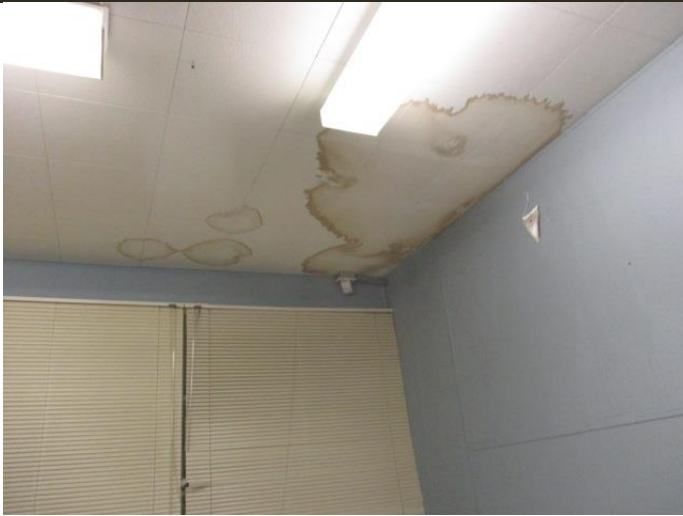
Photo 24 | Location: 1<sup>st</sup> Floor – Classroom #3 (117)  
Description: Mould Growth on Cellulose Ceiling Tiles

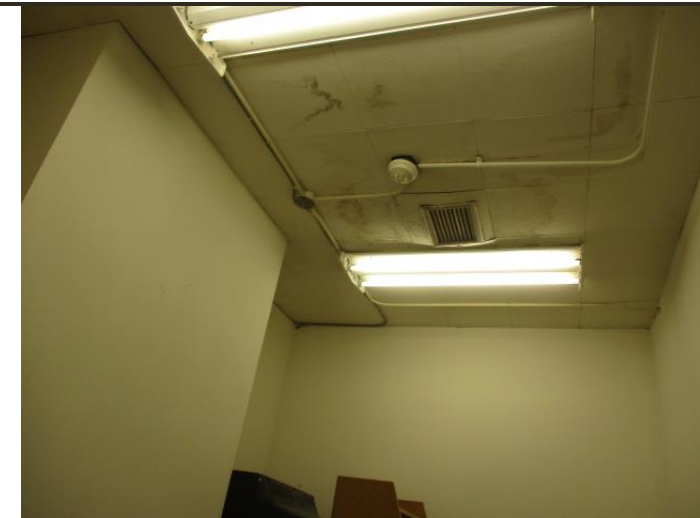
Photo 27 | Location: 1<sup>st</sup> Floor – Fine Arts (110)

Description: Water Damage/Leaks

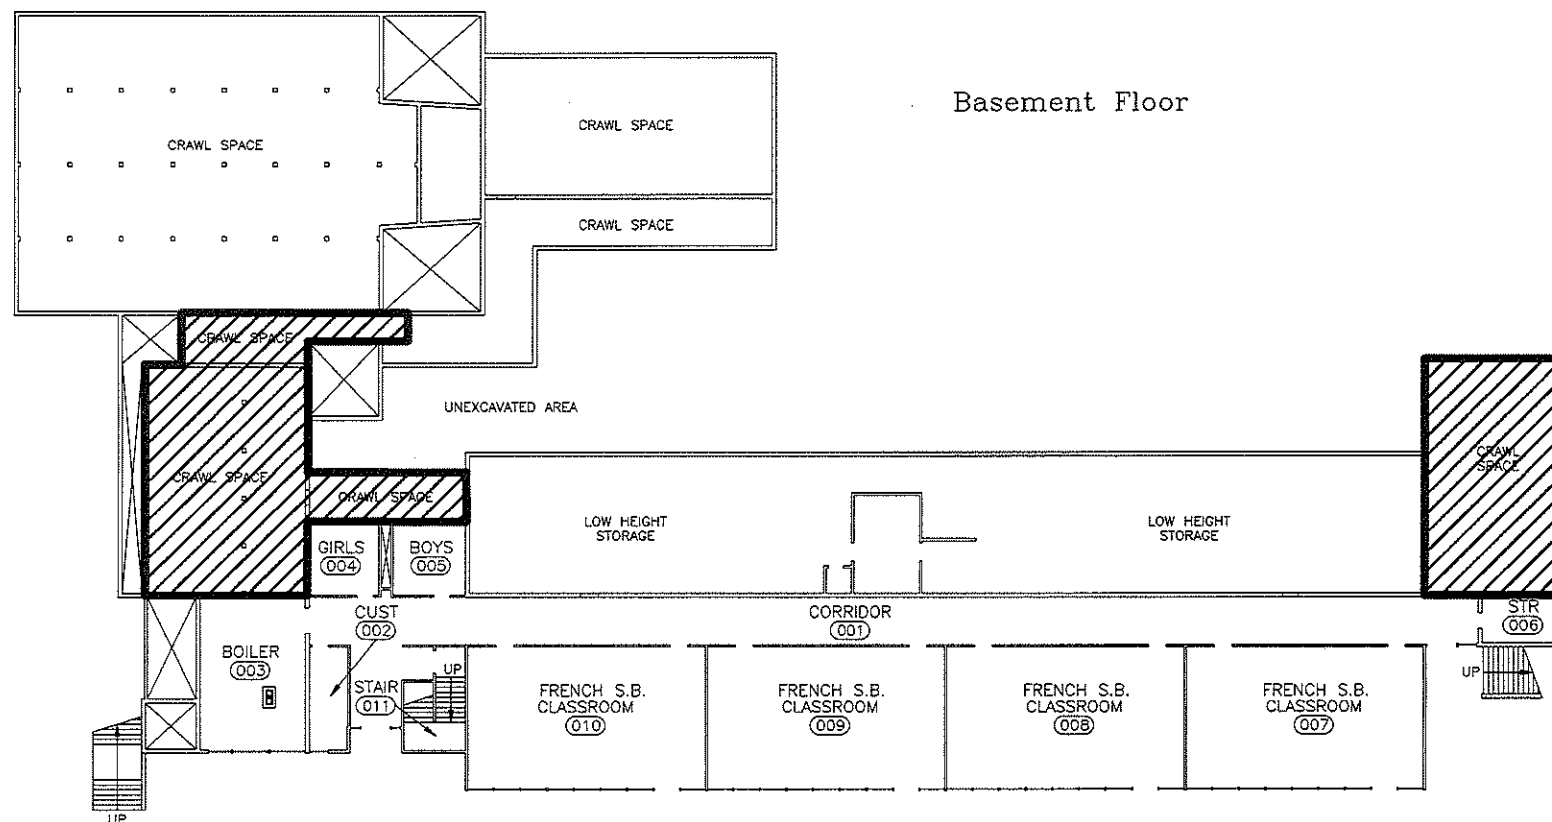
# Basement Floor

DO NOT ENTER THESE AREAS

A single crawlspace encompasses the entire school and a portion of the crawlspace was identified as being contaminated with asbestos. Entry into the crawlspace can be gained from the two wall hatches located on the Basement Level or from two floor hatches located on the Main Floor. No asbestos containing materials or debris was observed in the Low Height Storage Area. The location of the asbestos contaminated crawlspaces have been identified below:

The presence of asbestos debris on the crawlspace floor poses a health hazard to employees entering the space without wearing the proper personal protective equipment. We recommend that access to the crawlspace areas North & South of the Low Height Storage Area be restricted to all persons by appropriate signage and entry into the crawlspaces will require employees to wear a half-mask respirator equipped with P100 filter cartridges and disposal Tyvek (or similar) disposable coveralls.

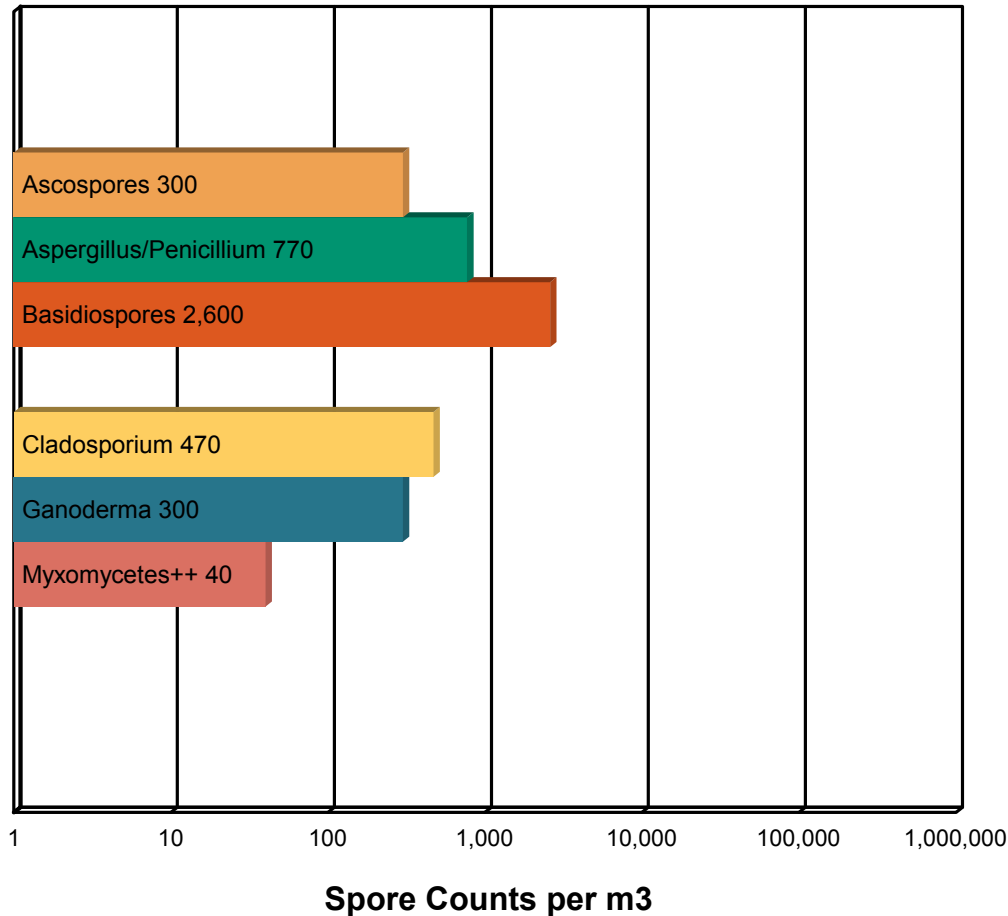
BASEMENT - CORRIDOR,  
EAST END  
6479-S10

### Spore Trap Report: Total Counts

\* The chart is displayed using a logarithmic scale. Bar size is not directly proportional to the number of spores.
