# Expansion Program: Project Definition Report

## Cloverley Elementary School

School District No. 44 (North Vancouver)  
November 10, 2022

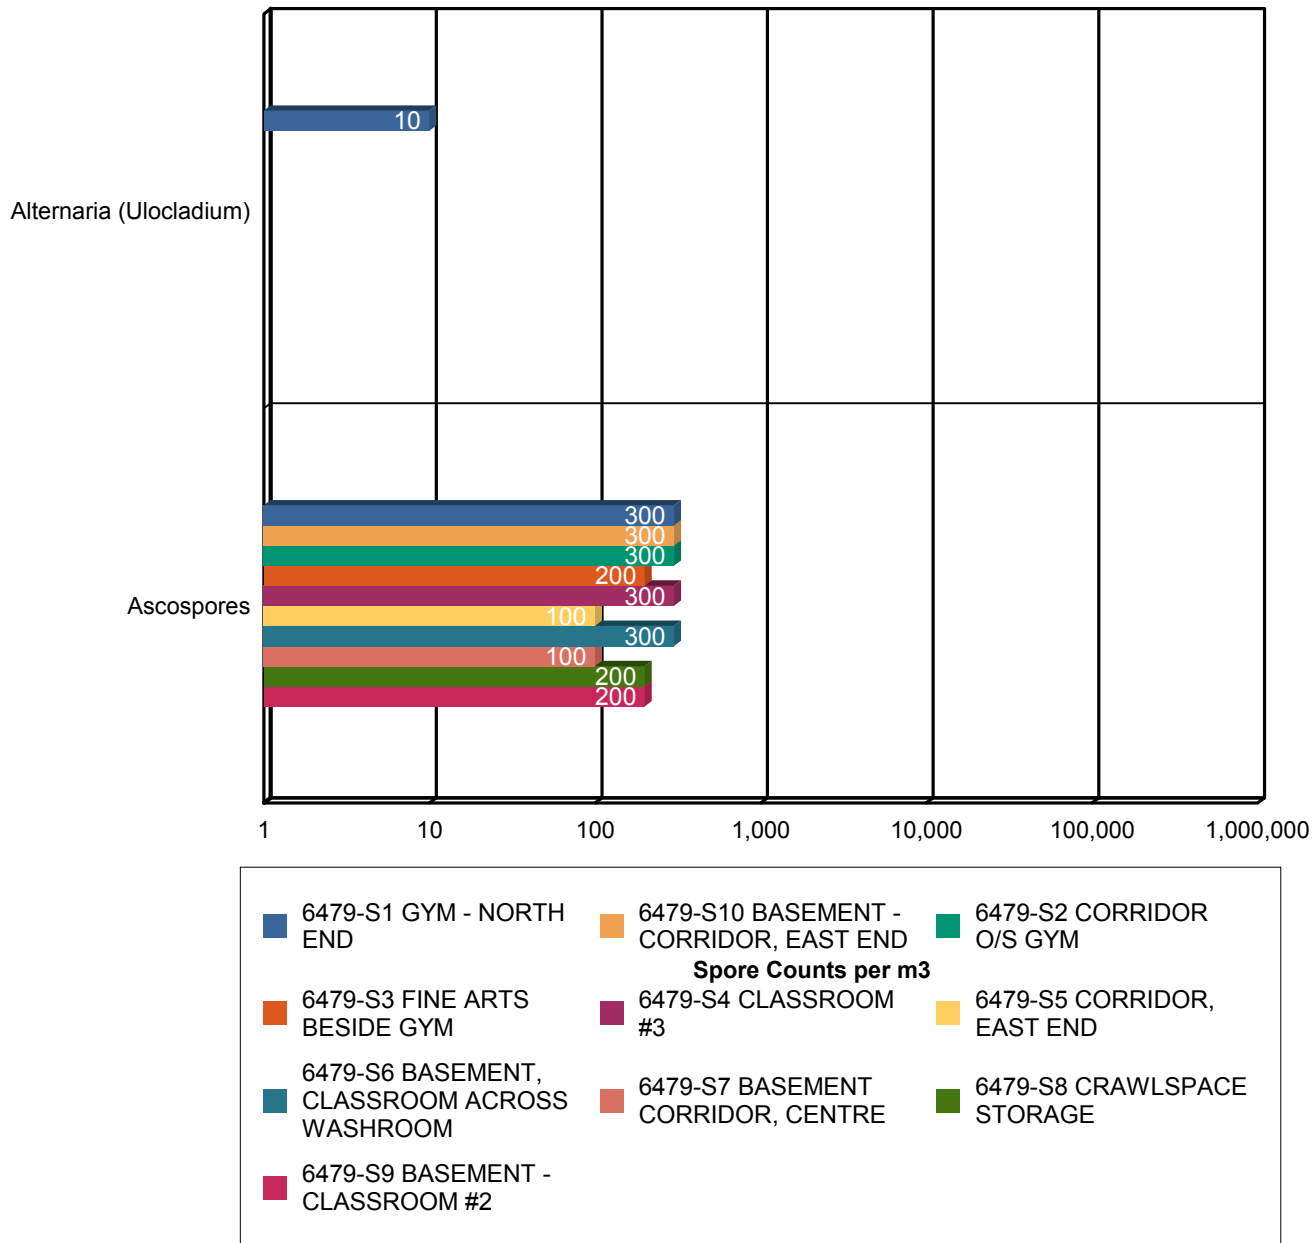
### Background Comparison Chart

\* The chart is displayed using a logarithmic scale. The bar size is not directly proportional to the number of spores.

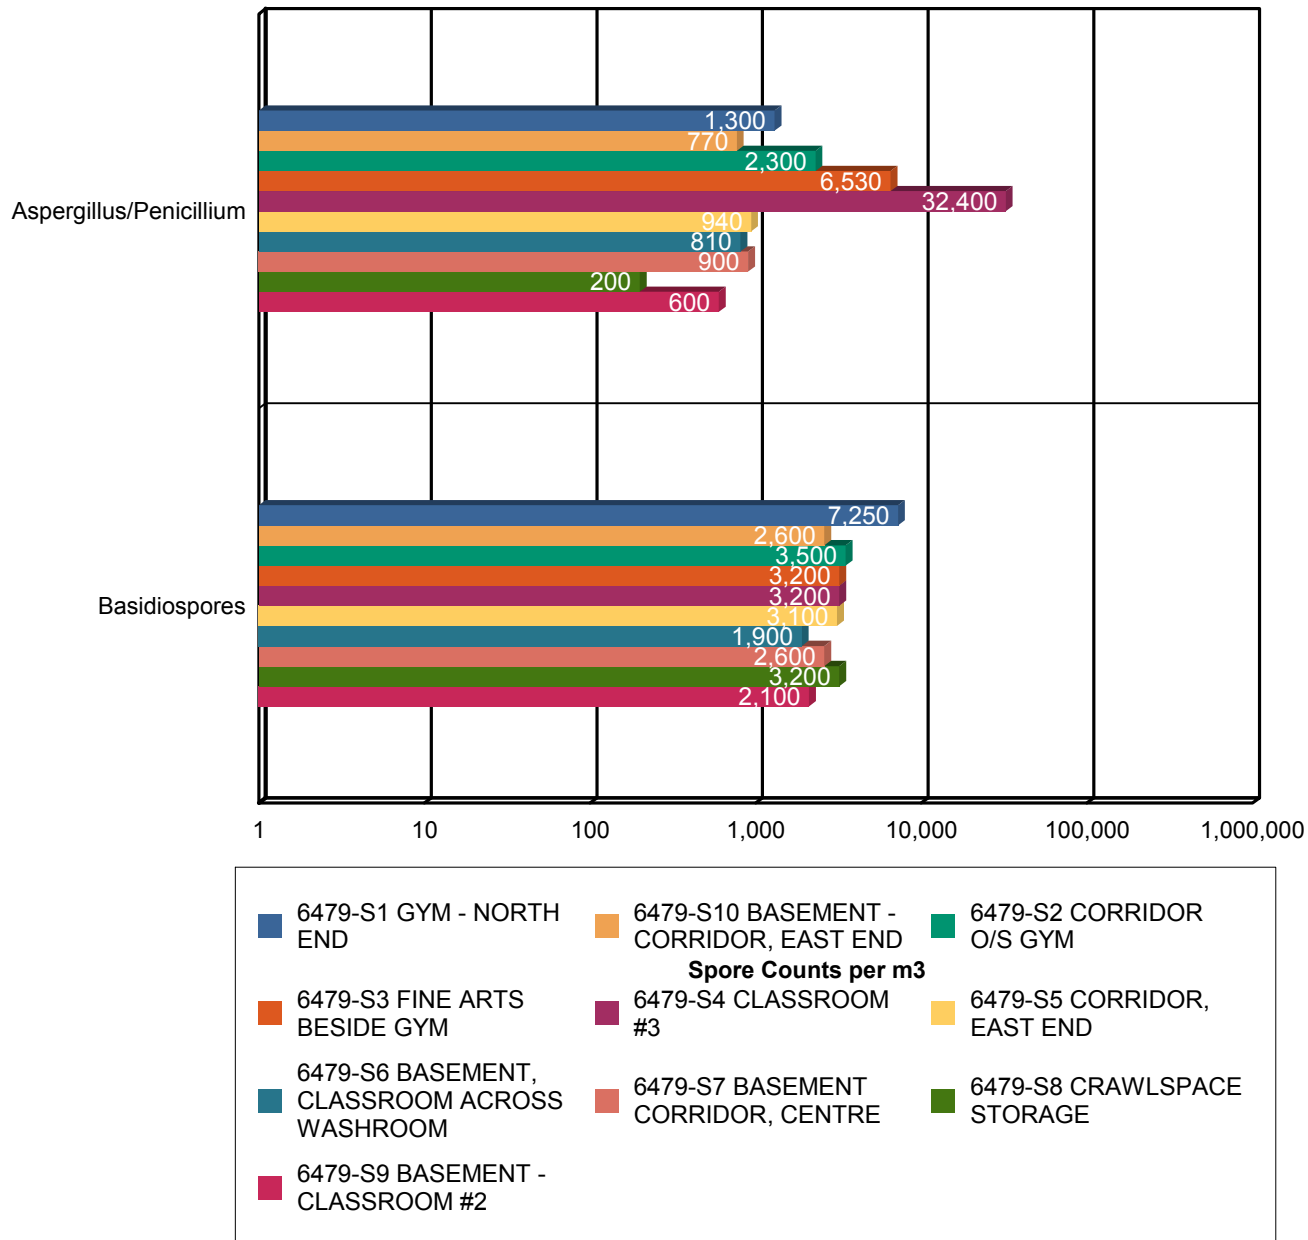
### Background Comparison Chart

\* The chart is displayed using a logarithmic scale. The bar size is not directly proportional to the number of spores.

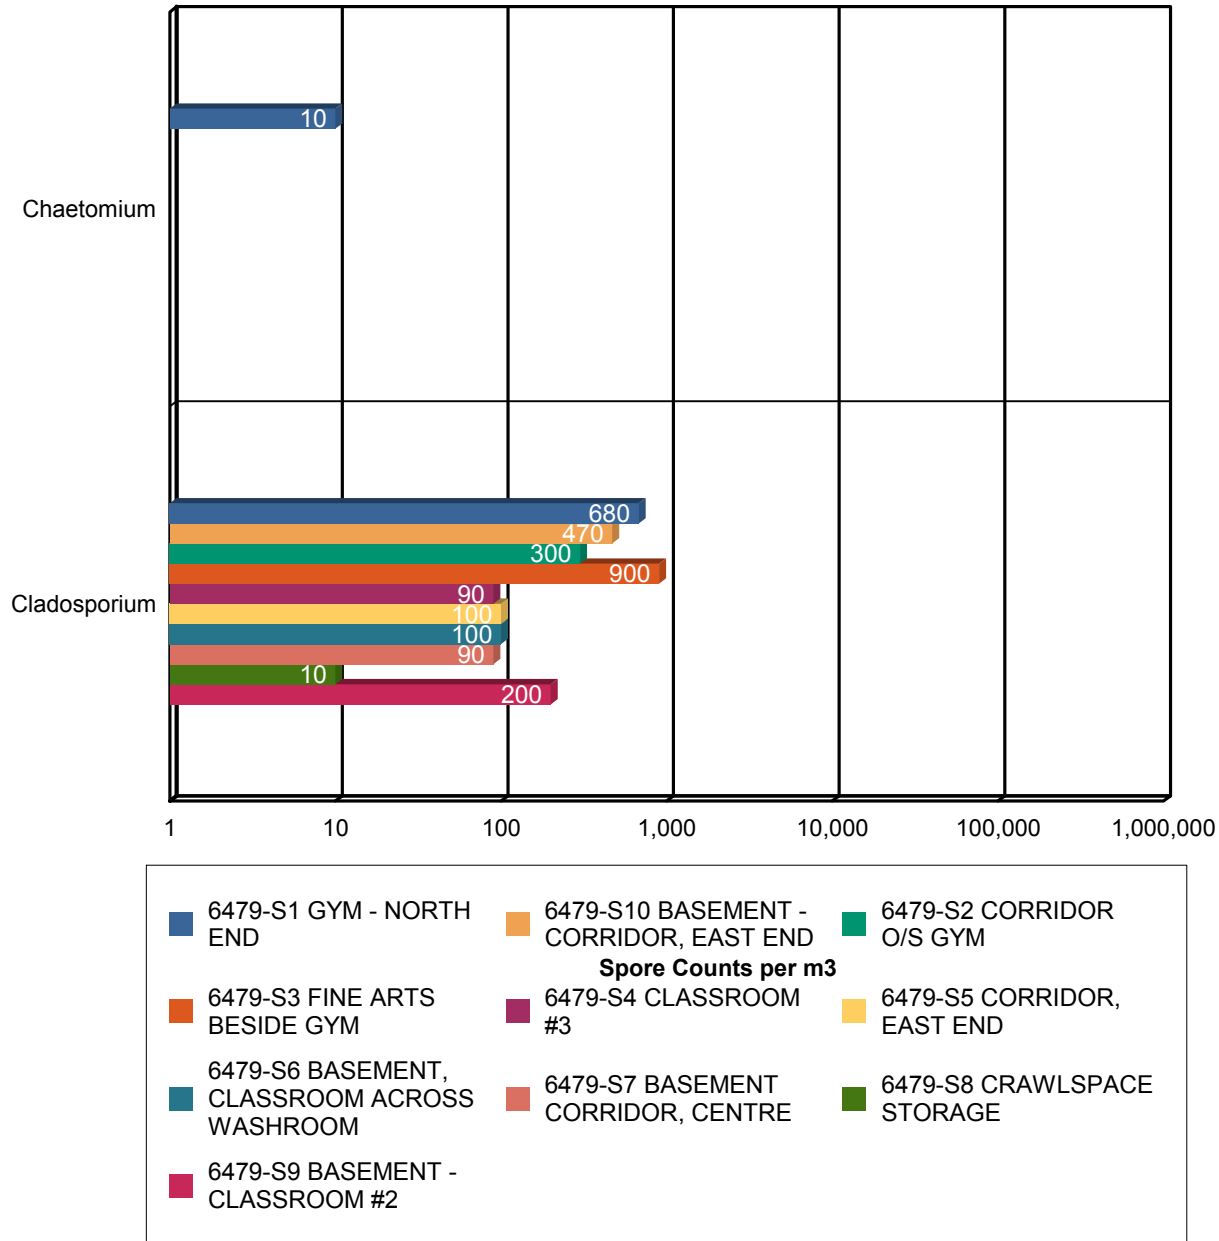
### Background Comparison Chart

\* The chart is displayed using a logarithmic scale. The bar size is not directly proportional to the number of spores.

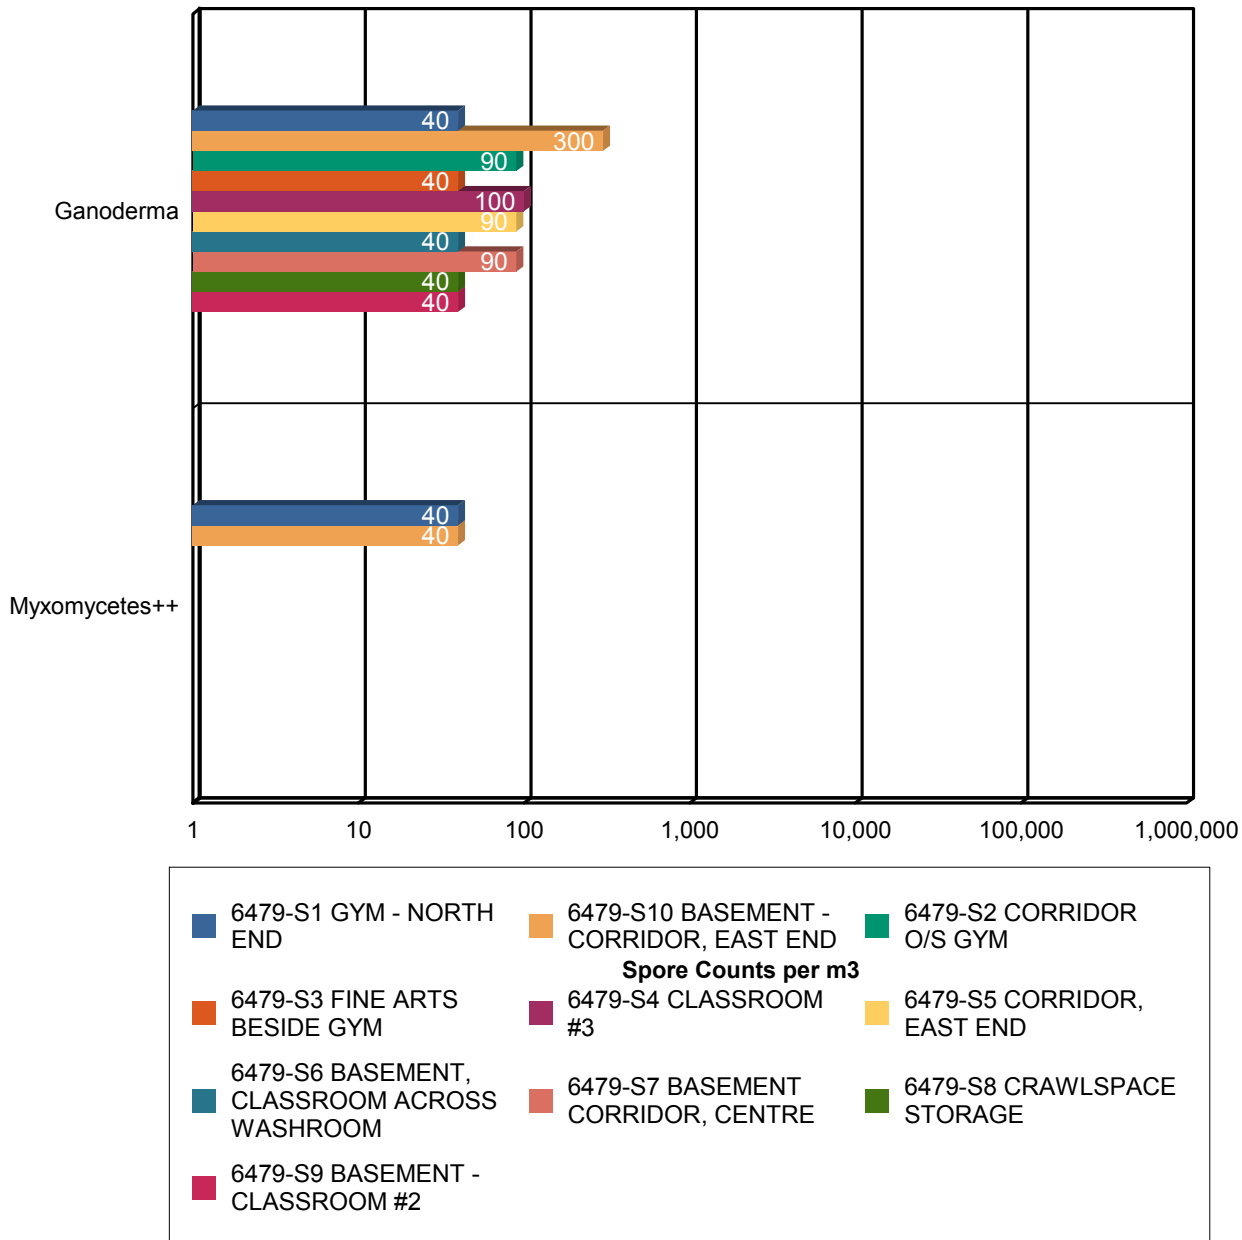
### Background Comparison Chart

\* The chart is displayed using a logarithmic scale. The bar size is not directly proportional to the number of spores.

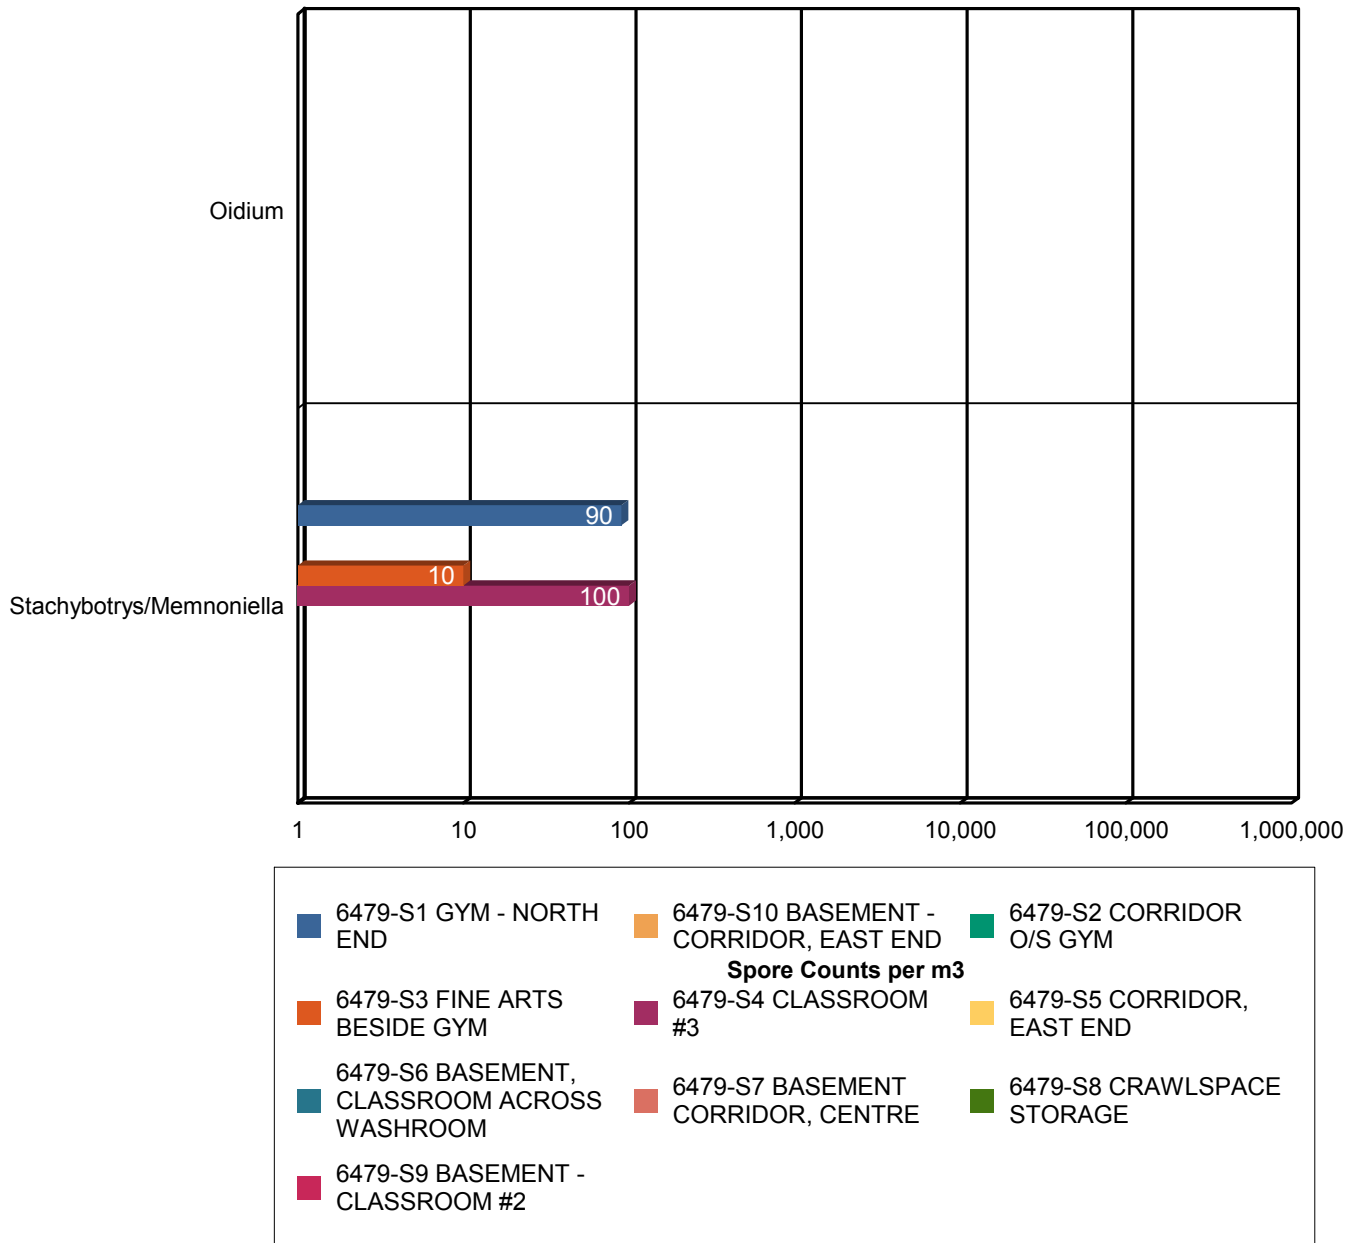
### Background Comparison Chart

\* The chart is displayed using a logarithmic scale. The bar size is not directly proportional to the number of spores.

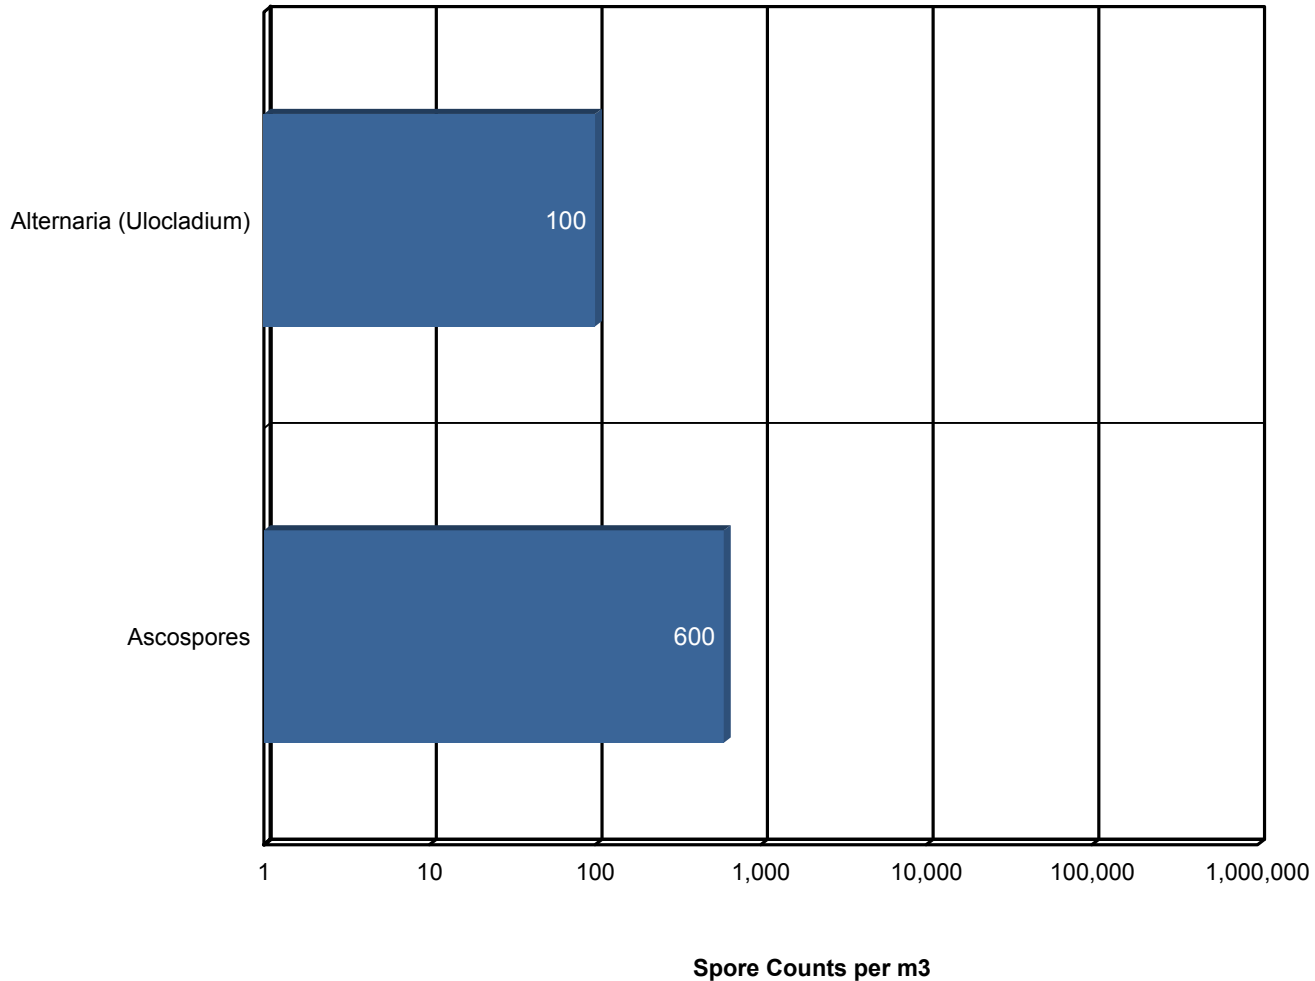
### Background Comparison Chart

■ 6479-S11 OUTSIDE - WEST SIDE

\* The chart is displayed using a logarithmic scale. The bar size is not directly proportional to the number of spores.

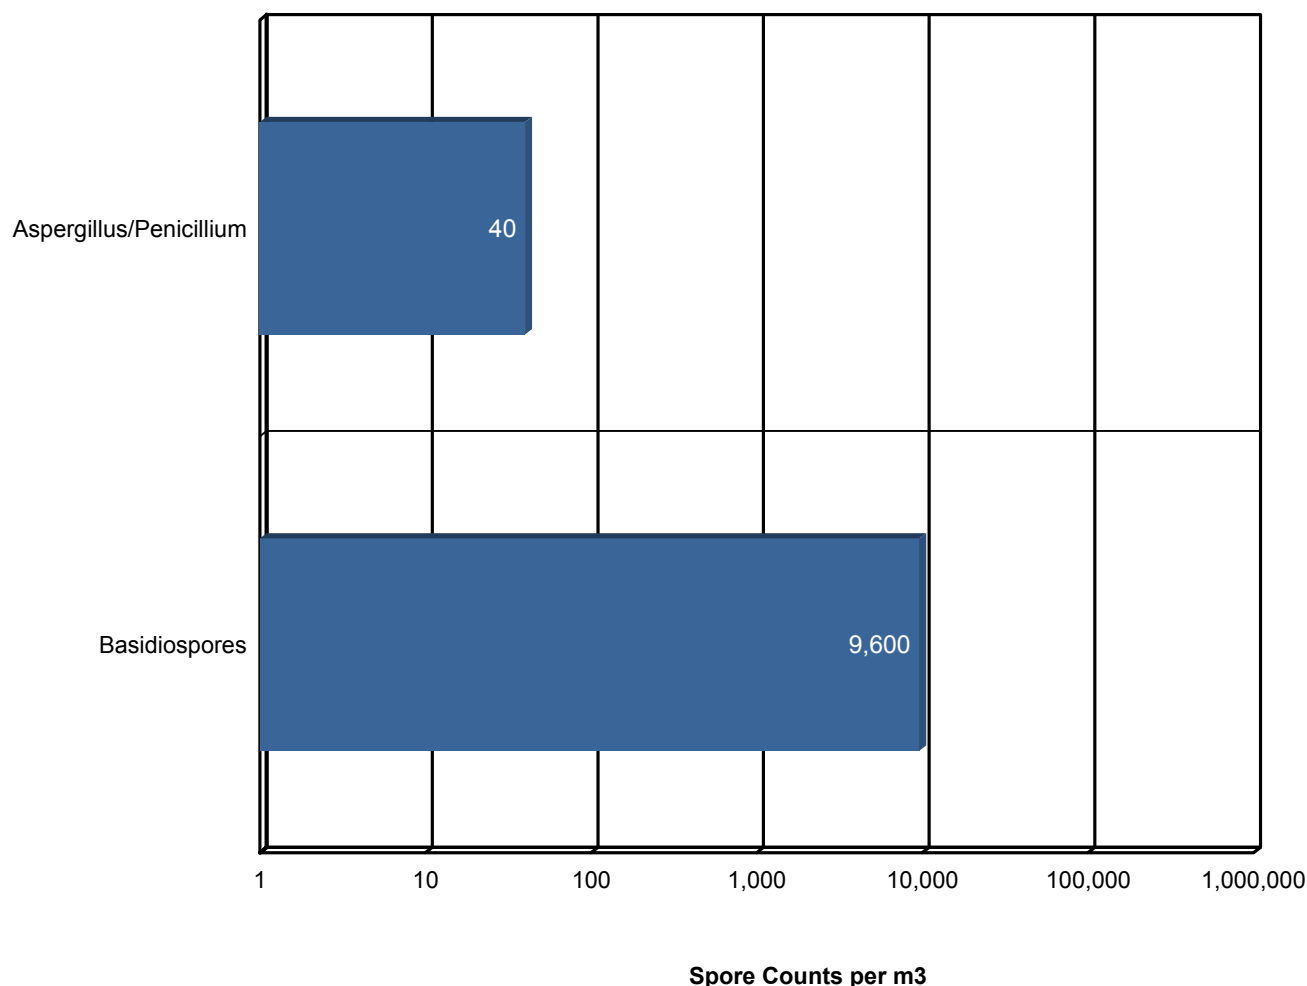
### Background Comparison Chart

\* The chart is displayed using a logarithmic scale. The bar size is not directly proportional to the number of spores.

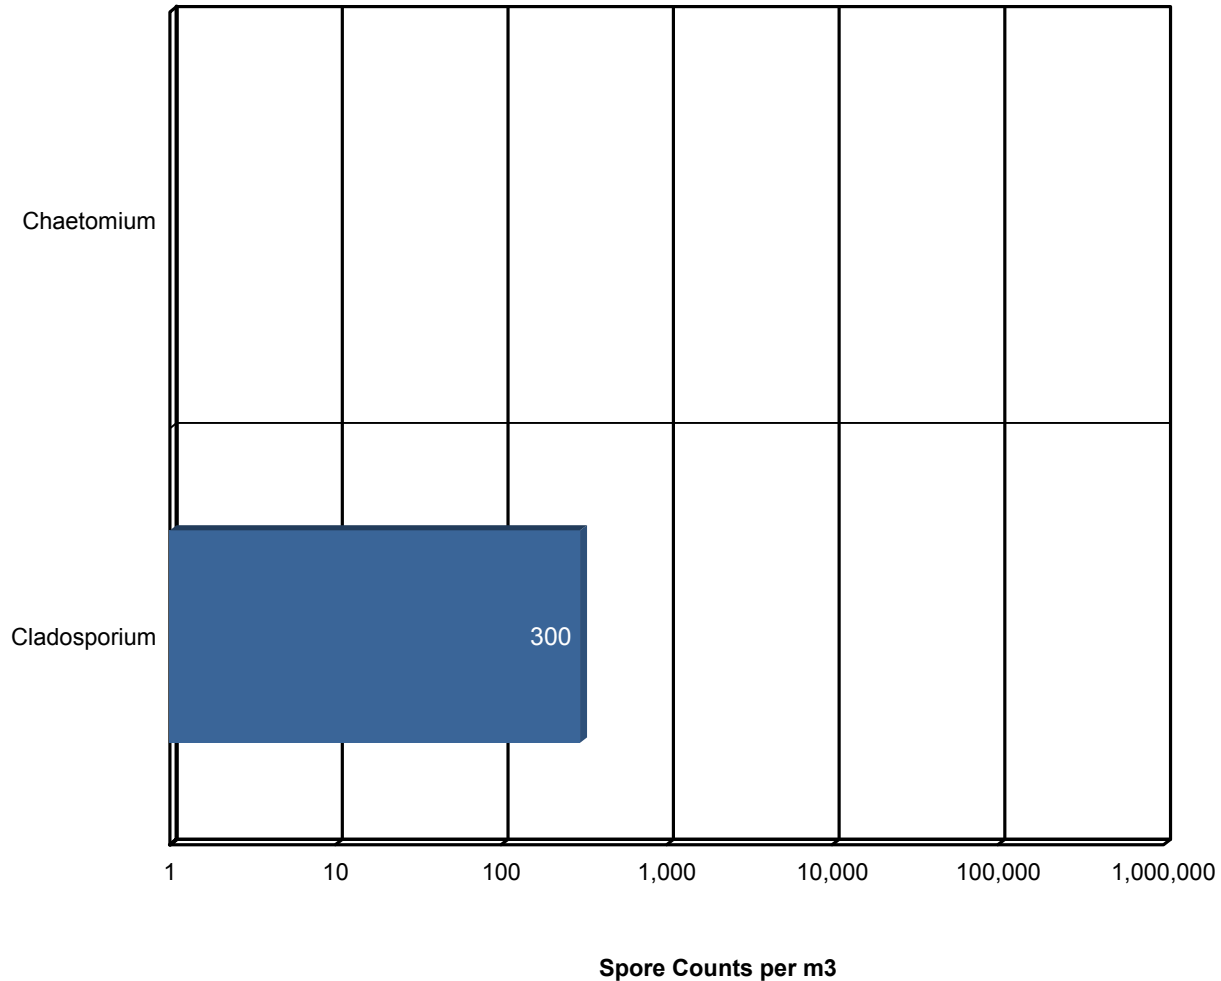
### Background Comparison Chart

■ 6479-S11 OUTSIDE - WEST SIDE

\* The chart is displayed using a logarithmic scale. The bar size is not directly proportional to the number of spores.

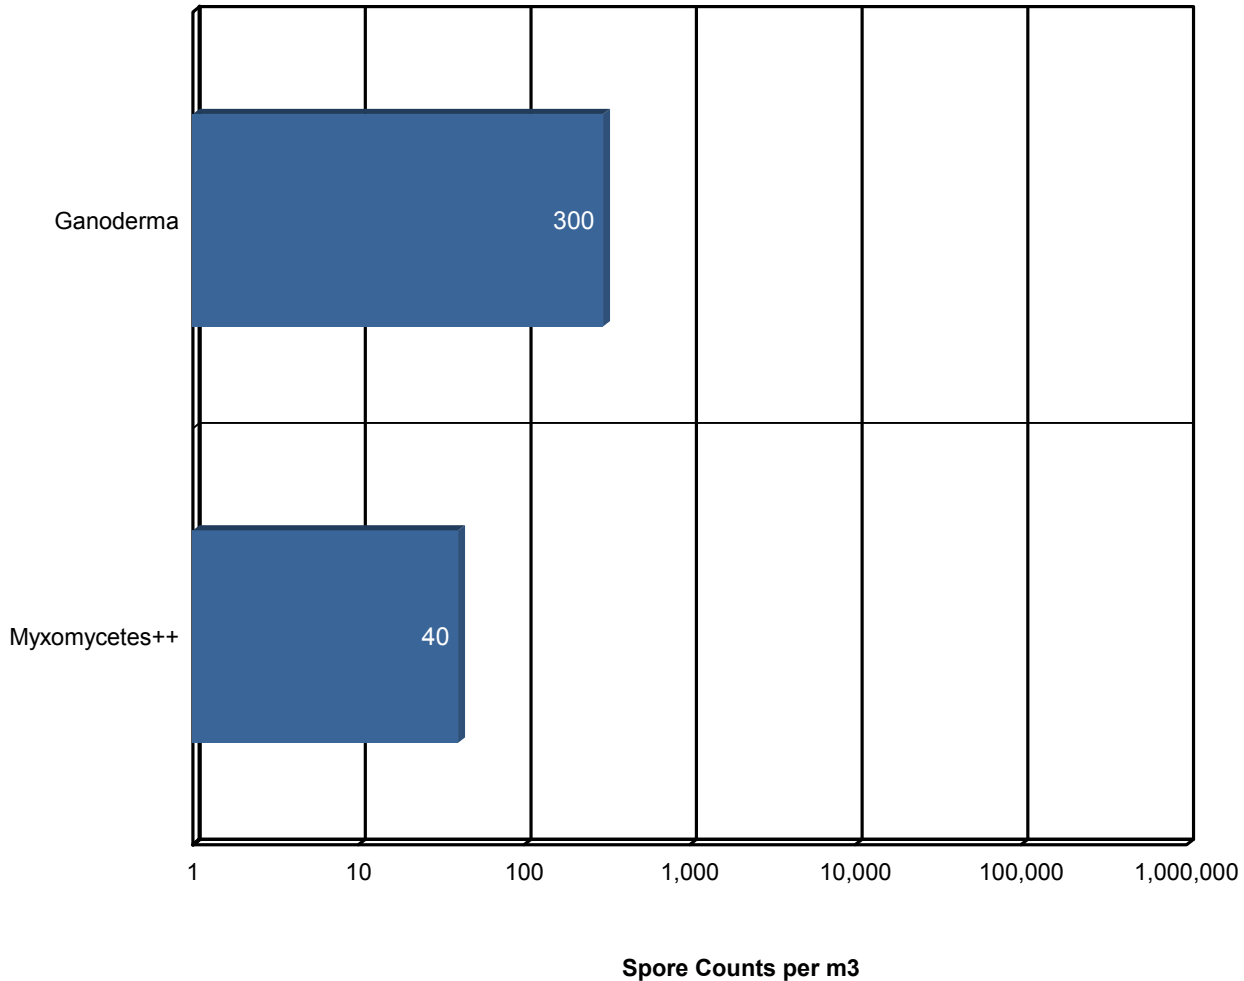
### Background Comparison Chart

\* The chart is displayed using a logarithmic scale. The bar size is not directly proportional to the number of spores.

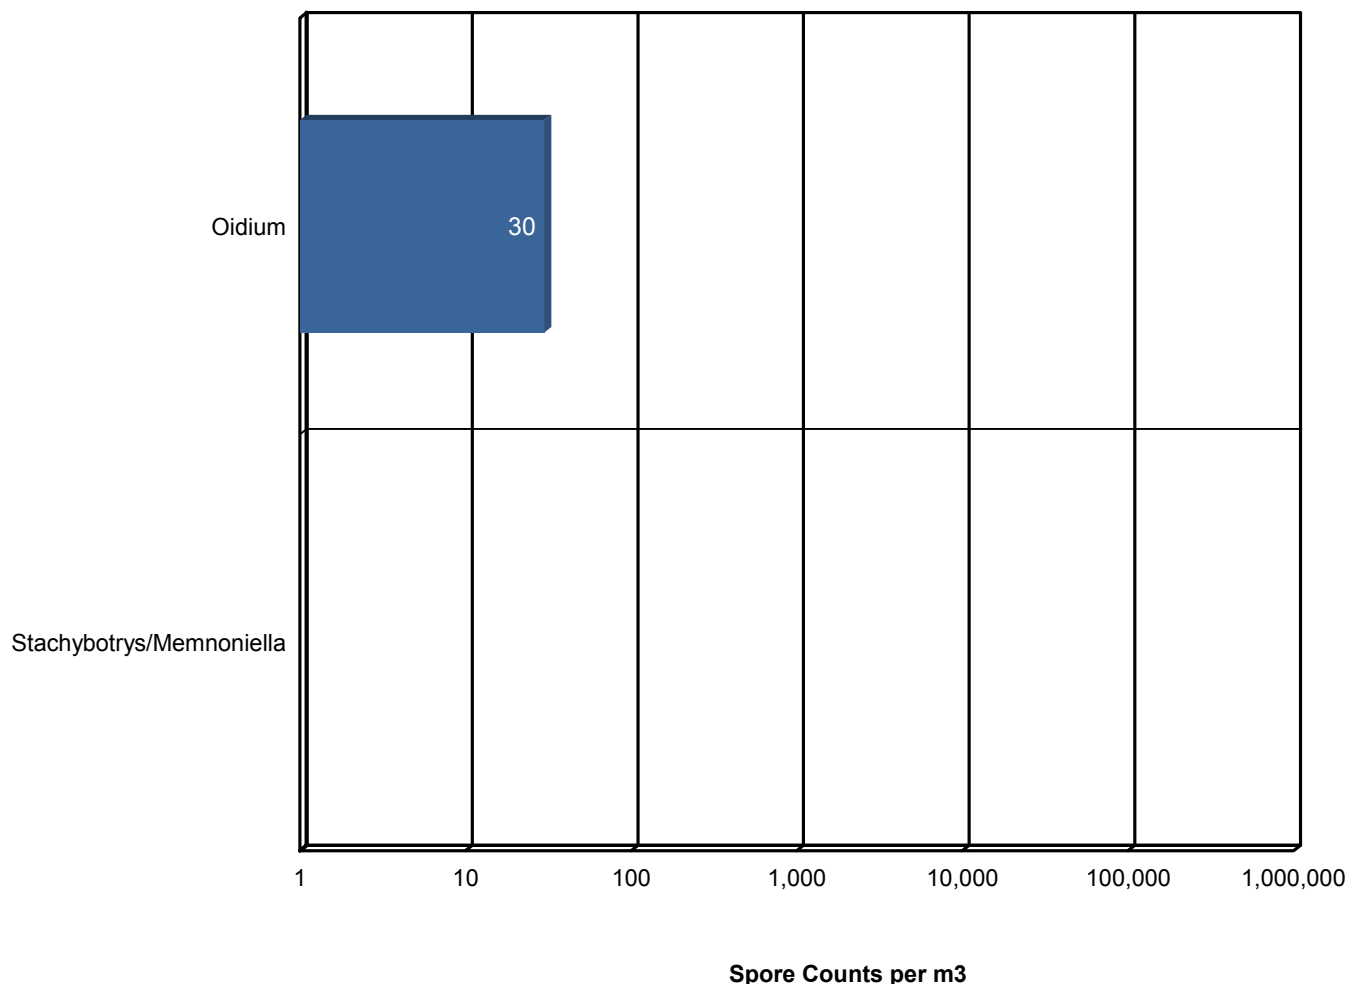
### Background Comparison Chart

■ 6479-S11 OUTSIDE - WEST SIDE

\* The chart is displayed using a logarithmic scale. The bar size is not directly proportional to the number of spores.
